# Dumbarton Oaks Park Hydrologic Analysis Update, September-November 2011

By Zoe Kulakowski  
Geological Society of America-GeoCorps™ America  
Geoscientist-In-Park  
December 2011

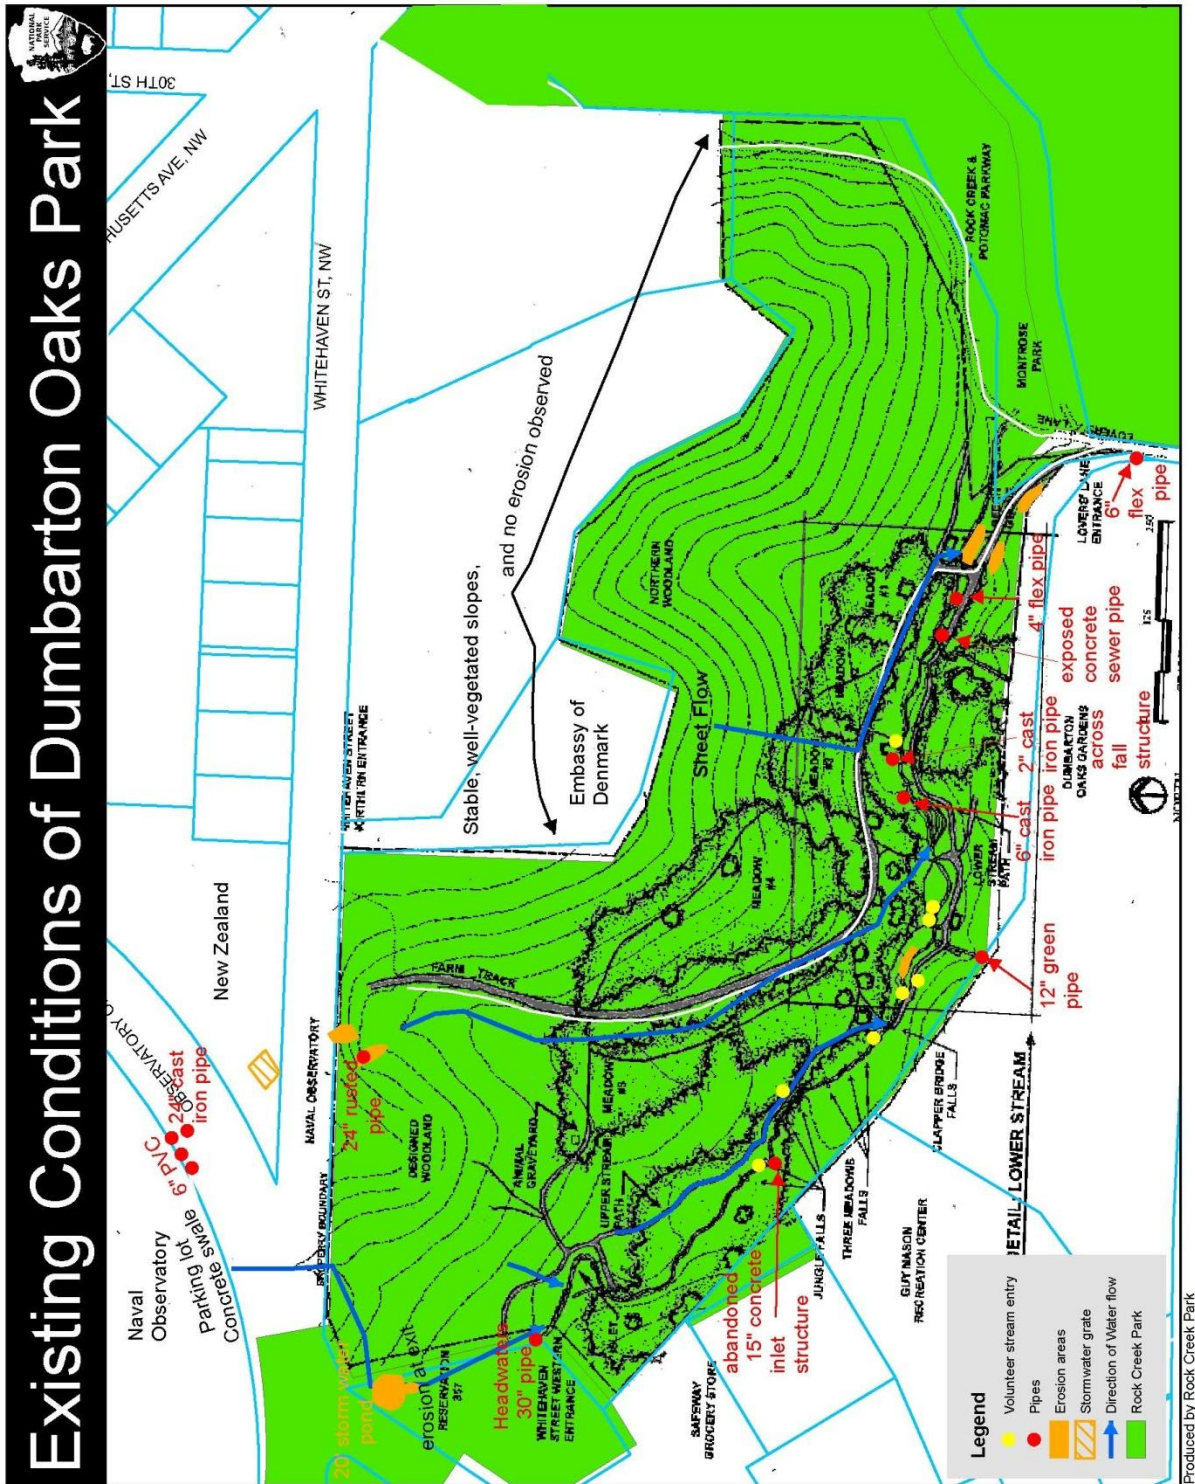
Figure 9: Existing Conditions of Dumbarton Oaks Park

Figure 9 summarizes field observations on the Cultural Landscape Report (2000) base map of existing conditions, piping, and volunteer stream entry locations for the Dumbarton Oaks Park area. Existing conditions included areas where runoff has eroded soil and vegetation, gullies, and areas where corrective measures are successfully controlling erosion. Appendix B provides photo documentation of erosion from runoff leaving Dumbarton Oaks down their north slope and into the park. Appendix C provides photo documentation of runoff sources into Dumbarton Oaks Park. The Figure 10 photos document two areas along the stream path where temporary fencing allows the accumulation of fallen leaves and re-establishment of vegetation. A poorly maintained storm water pond, with a possible uphill facility (to the northwest of Figure 8, GPS Location 15 where 6"X 6" posts lie on the land surface to control direction and rate of runoff), is located outside park property on Federal property identified as Reservation 357. These two areas are severely overgrown with porcelain berry covering the possible uphill facility and understory brush in the storm water pond. No flow for any precipitation event was observed exiting the flex pipes, the 2" cast iron pipe, the two southwestern-most Naval Observatory 6-inch PVC pipes, or the abandoned 15 inch concrete inlet structure. The exit location for the 2" cast iron pipe is unknown. The flex pipes and 6-inch PVC pipes may discharge water during higher precipitation events.

The only constant source of flow into the park is the 30 inch Headwaters pipe (GPS Location 1). It provides the stream baseflow and receives discharges from an unknown source that emits a fan blower sound with a surge in flow observed 5 seconds later emerging from the 30 inch pipe. The 18 inch Headwaters pipe from the Georgetown University Building (Parsons 2003) has intermittent flow that appears unrelated to precipitation events. The pipe had no discharge the day after precipitation (0.41 inches on 11/29/11) and then a sudden discharge that lasted at least 10 minutes. The velocity of this flow was significantly less than that observed at the 30 inch pipe. It is possible that de-chlorinated swimming pool bottom drain water and non-contaminated chiller water may be the intermittent sources of either pipe (Personal communication, Jessica Demoise, DC Water, 2011). The location of the 18-inch pipe is not shown on Figures 8 and 9 because it was discovered 11/29/2011 after the maps had been prepared. Considering water depth and concurrent conditions at the 30 inch pipe on 11/30/2011, the 18 inch pipe discharge was about a fourth of that observed at the 30 inch pipe. The 12 inch green pipe (GPS Location 27-28 area) draining Dumbarton Oaks also exhibits intermittent flow with higher flows occurring during precipitation events. Tropical Storm Lee

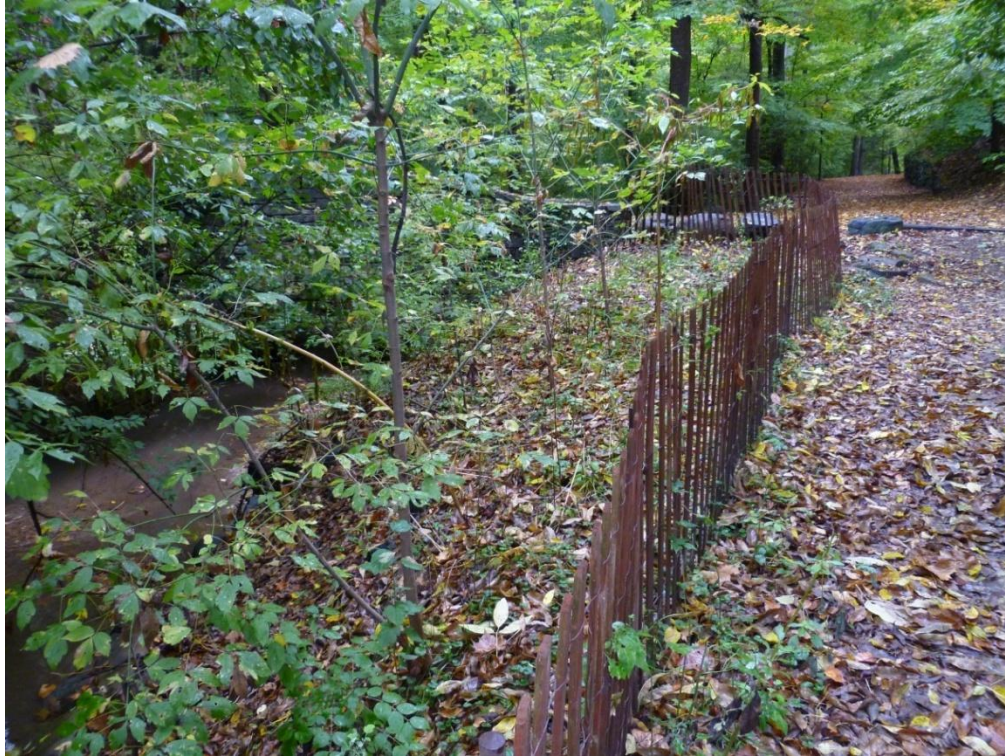
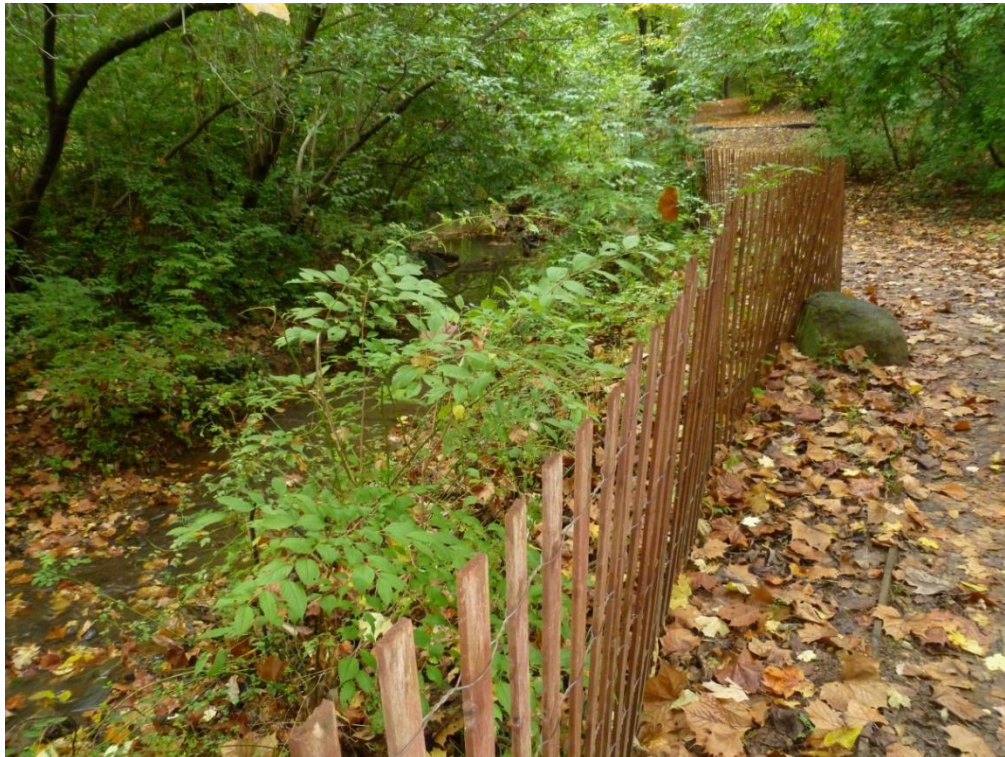
Figure 10: Benefit of Temporary Fencing - These photos taken along the Stream Path show the benefit of temporary fencing for re-vegetation, accumulation of leaves, and slope erosion control.

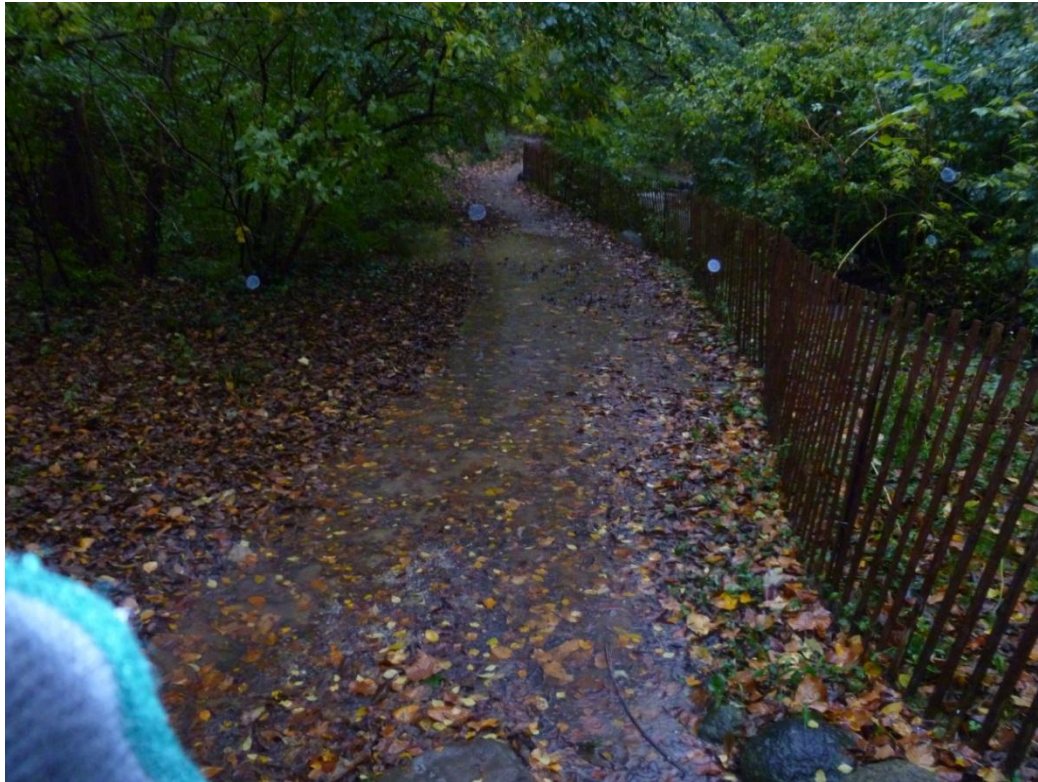
Three Bridge Falls (E) at 10:01A – water volume exceeds the capacity on the south side of the structure.

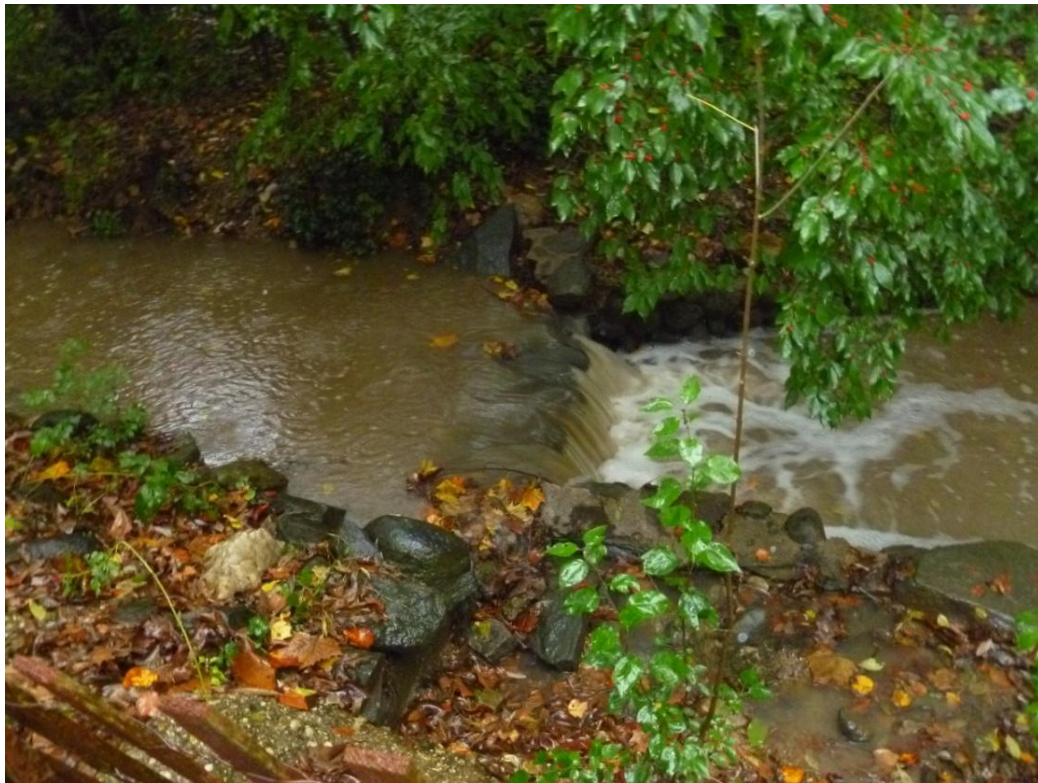
Three Bridge Falls (W) at 10:04A – water volume exceeds the capacity on both sides of the structure.

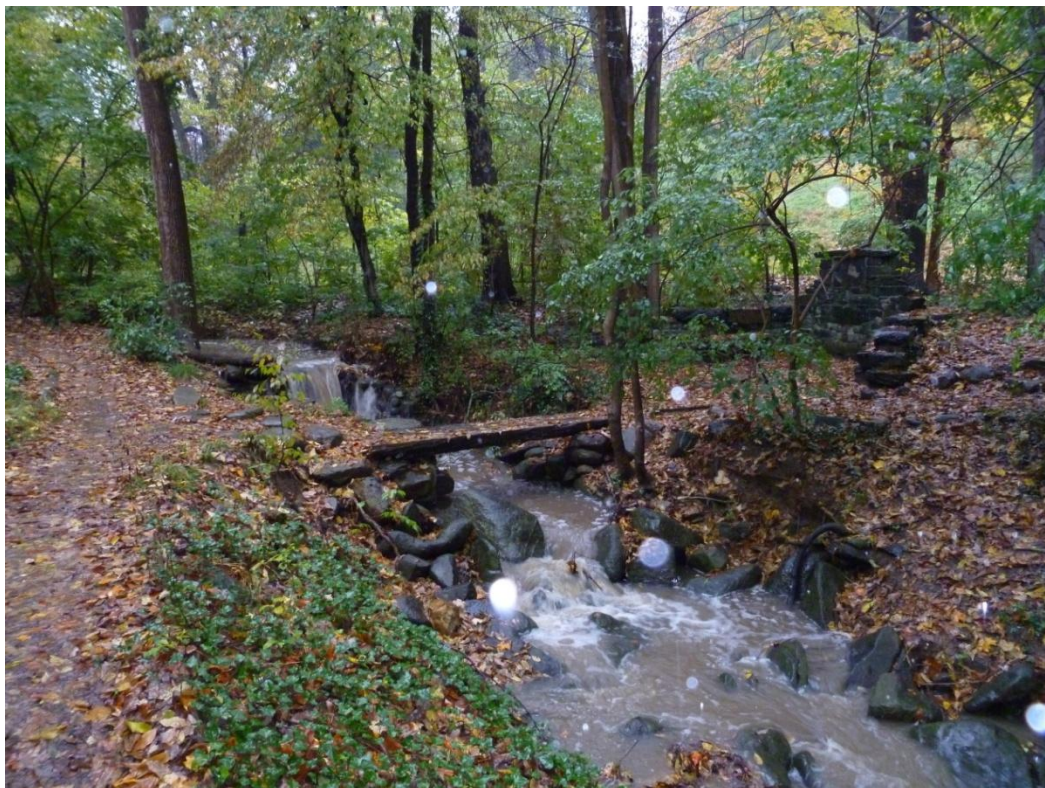
(Above) Gray Arbor Memorial with the first of the Three Sisters Falls at 10:06A. The boulder lined stream section is handling the flow fine but the eastern most Three Sisters Falls has flow bypassing the structure on the north side as shown in detail in the following photo.

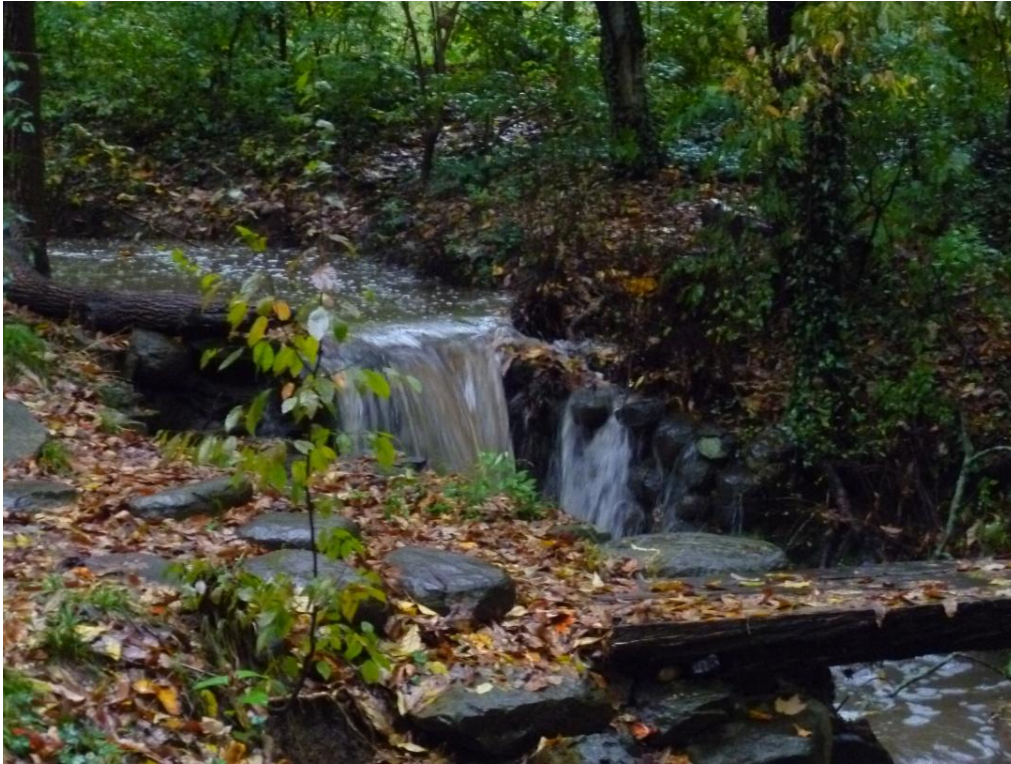
In spite of the humidity/raindrop compromised photo above, it is clear that the middle Three Sisters Fall has flow leaving the south side channel (10:07A). The Three Sisters Falls (W) handles the discharge but has past erosion from a volunteer tributary outside its north wing wall. Both waterfalls are below.

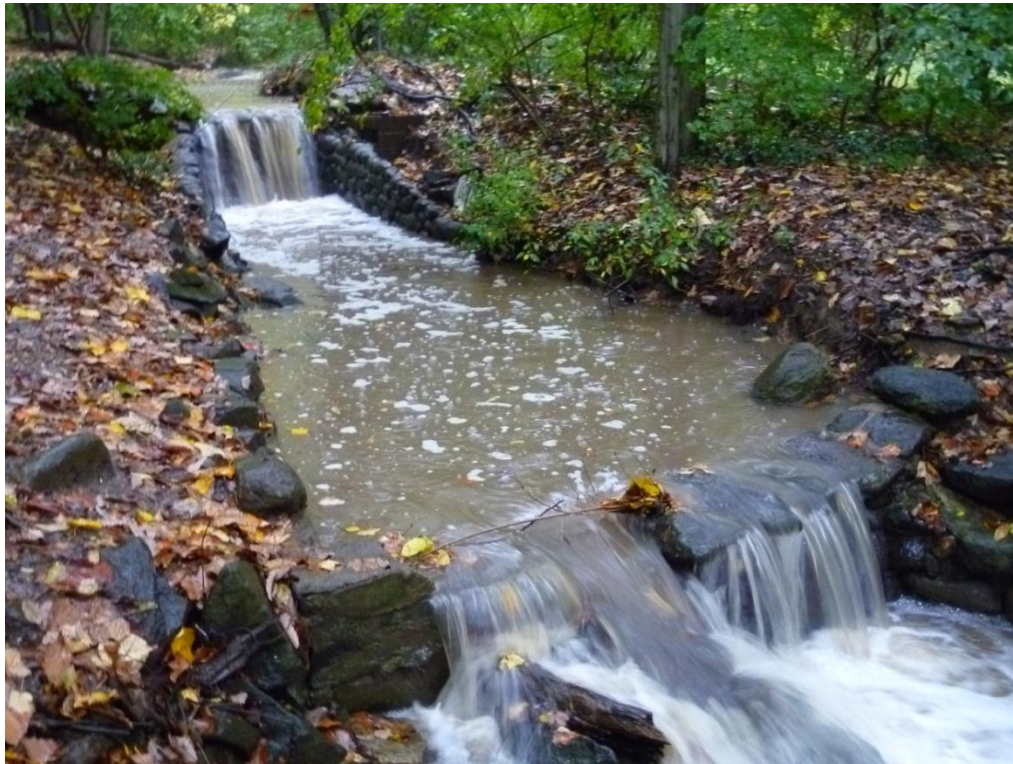
(Above photo) Laurel Pool at 10:08A is full and providing water storage. The eroded pool banks are not visible. Note that the incoming flow to Laurel Pool takes the shortest flow path along the north shore to the water fall. This is the cause of the north bank erosion. Any pool rehabilitation to fix this situation will require a hardened north bank (boulders or a stone wall). The following picture shows West Laurel Falls at 10:12A discharging into Laurel Pool (no capacity problems at this volume). The log damming the stream channel serves to increase creek storage by causing the upstream water to pool, but needs to be removed for higher flows. The volunteer tributary from the Farm Track drainage path was actively discharging on the north side of the north wing wall.

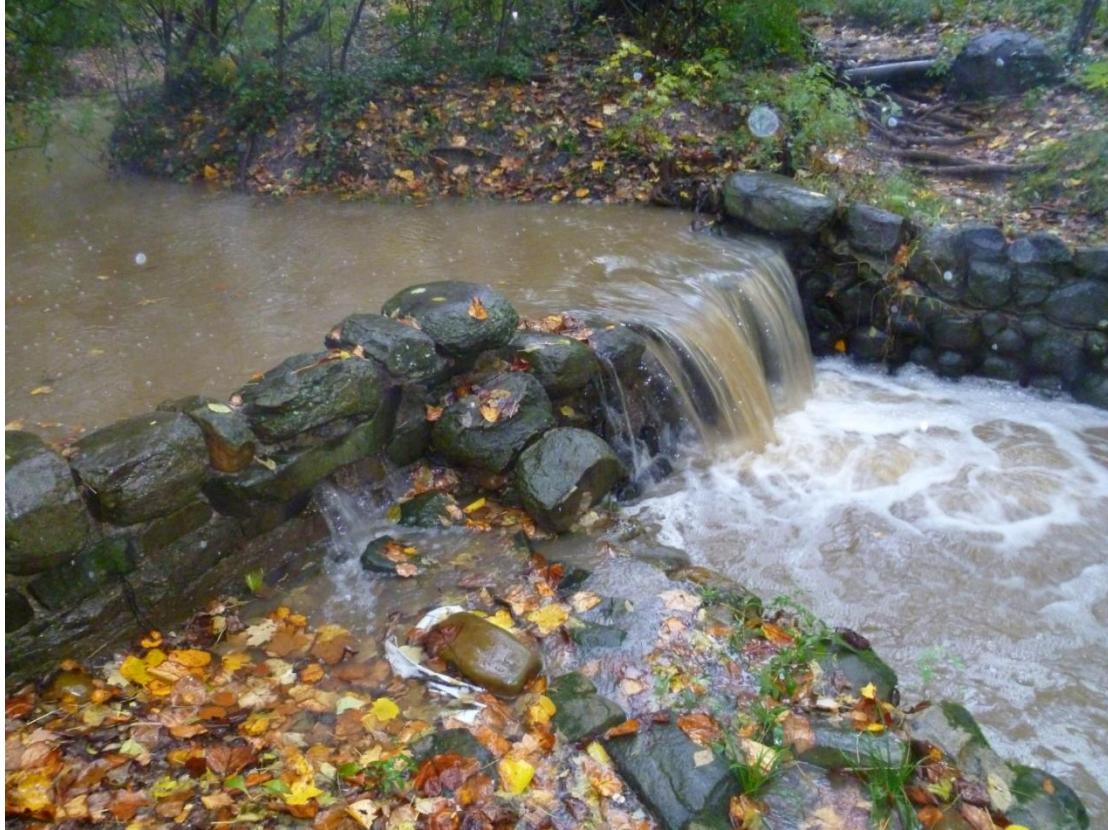
Old Water Wheel Falls at 10:15A has leakage through the fall structure on the south side. This leakage occurs during lower stage conditions also and should be repaired. Note the erosion on the north side of the fall structure from a volunteer stream that was not active on this date.

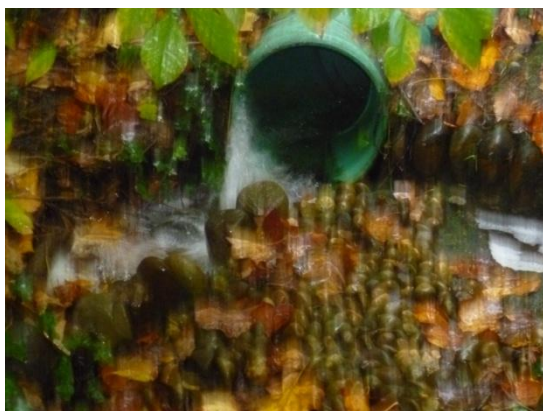
The following picture shows flow exiting the 12 inch green pipe in the pebble stream area at 10:17A. The pipe contains a bend forcing the higher flows to exit up the interior pipe wall. No note was made whether the overland flow down the pebble stream was also active as it was on October 13 and 19; dates that had less rainfall than 10/29 (0.72", 0.5", and 1.18", respectively). The overland flow on October 13 was observed to be approximately double that observed to be exiting the pipe (flow was too shallow to measure velocity either for the green pipe or the overland flow).

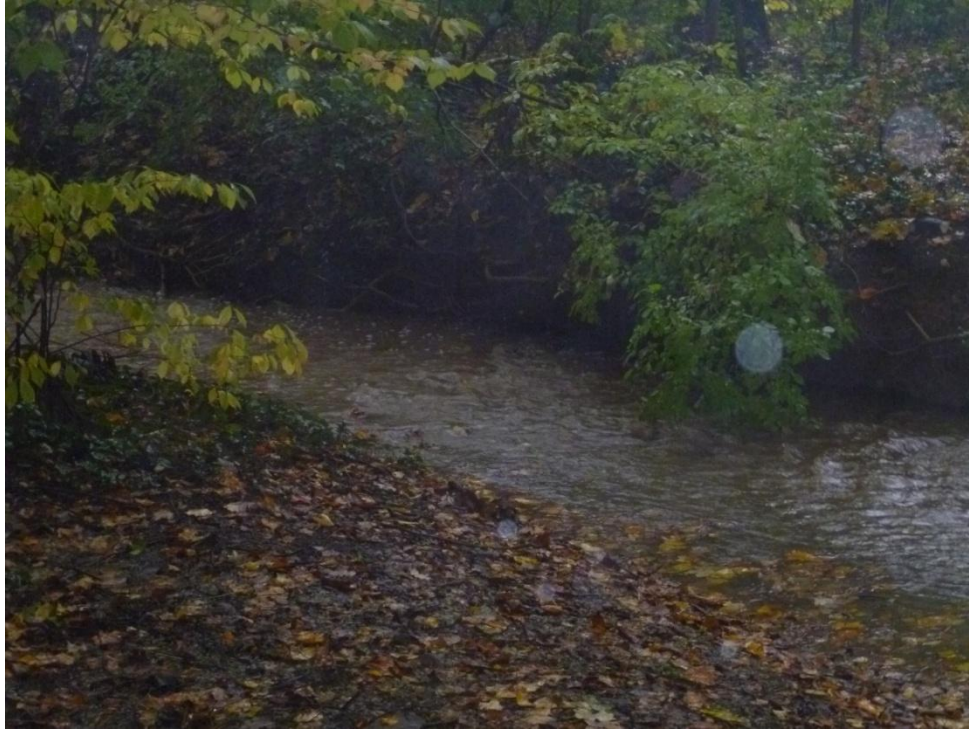
The stream channel (10:17A) between the Spring Grotto/Pebble Path and Arbor Falls has migrated north and is eroding the north bank exposing the roots of the remaining trees and plants. Bulb plantings on the top of the north bank are being eroded with every rain event. Alternatives to fix this situation include (1) the installation of a rock wall similar to those used by Beatrix Farrand for high velocity stream sections (2) the removal of sediment, followed by the addition of cobbles to create a wide, gently-sloping cobble-lined stream course, and (3) the armoring of the north bank with boulders to force the flow south. The channel is steep enough in this section to concentrate the flow into a narrow width (increasing the flow velocities) and even the armoring option should include a widening of the stream base to increase friction and slow the velocity. The following photo (10:18A) shows the upstream section and the beginning of the eroded section.

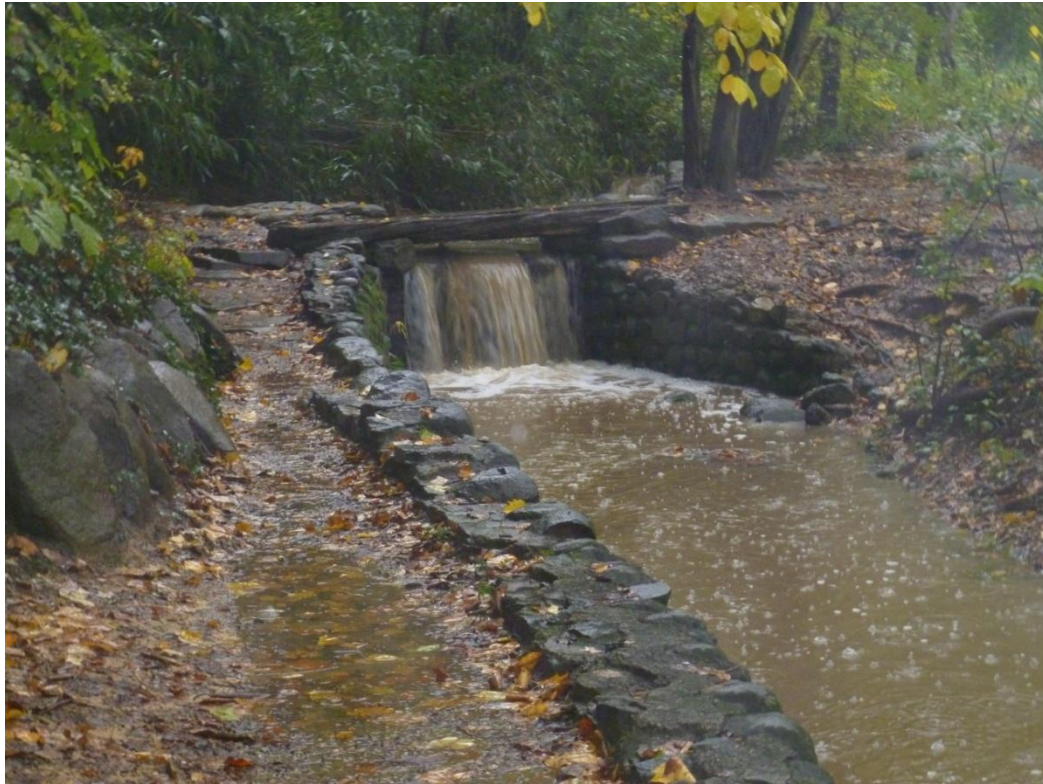
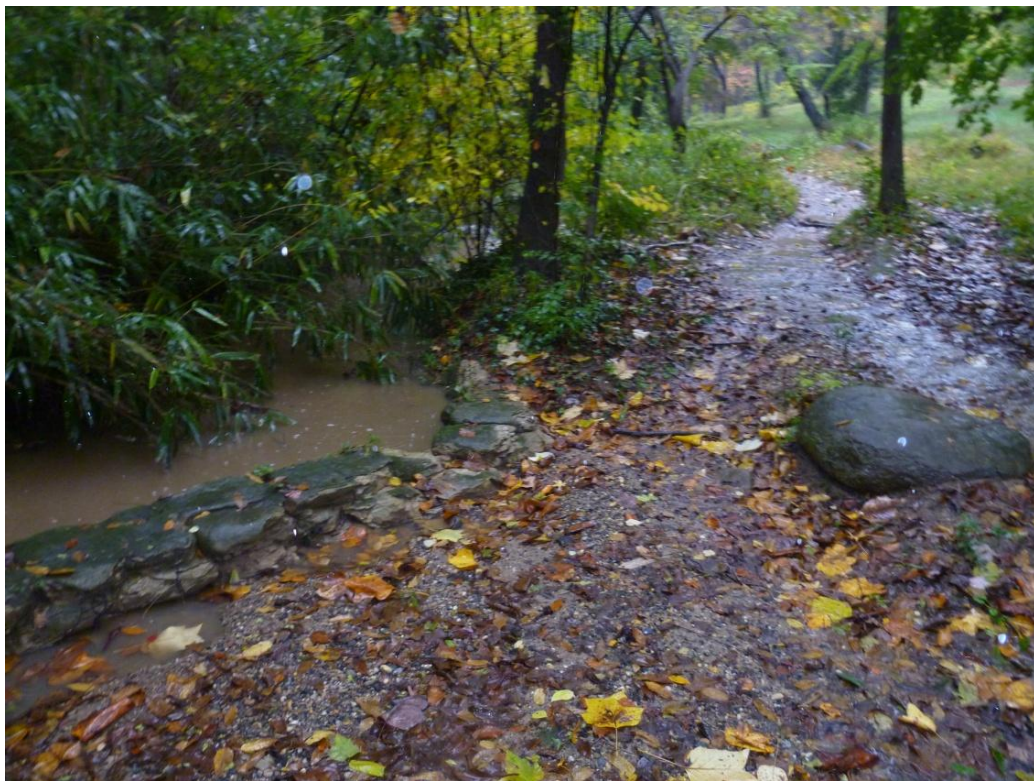
Upstream of Clapper Bridge Falls at 10:24A, the falls structure is providing storage and slowing the flow down by forcing the water to pool. This area is one of the pools needing sediment removal.

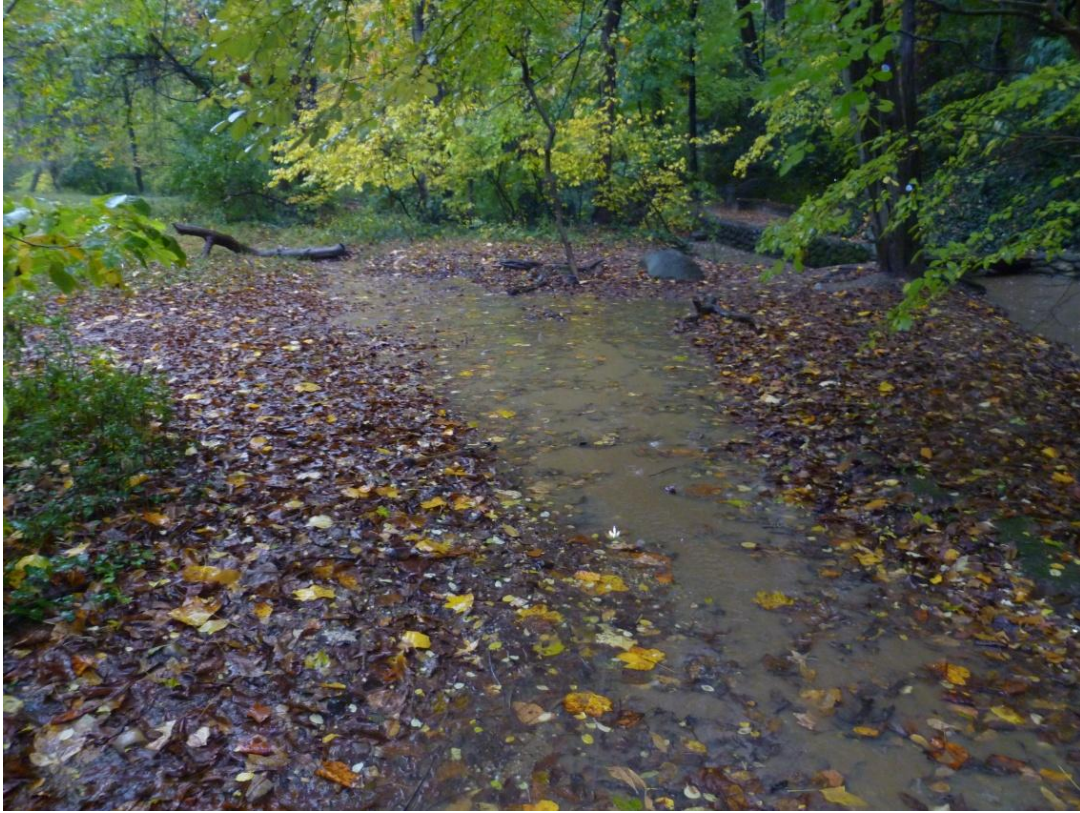
Water collecting on the stream path that may drain to Old Water Wheel Falls (10:24A).

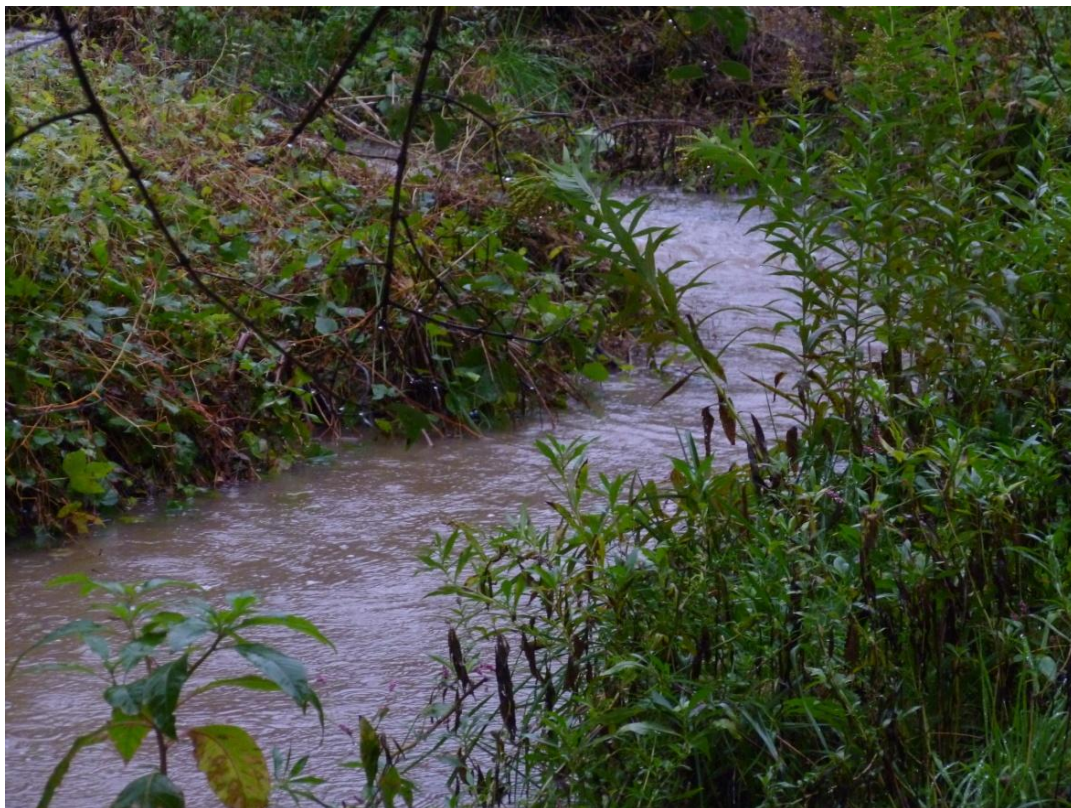
(Above photo) Looking east towards Clapper Bridge Falls, this picture (10:29A) shows that water follows the park trails and is transporting turbid water. The following pictures (10:31A and 10:32A) show the same trail to the west (but looking east and west, respectively).

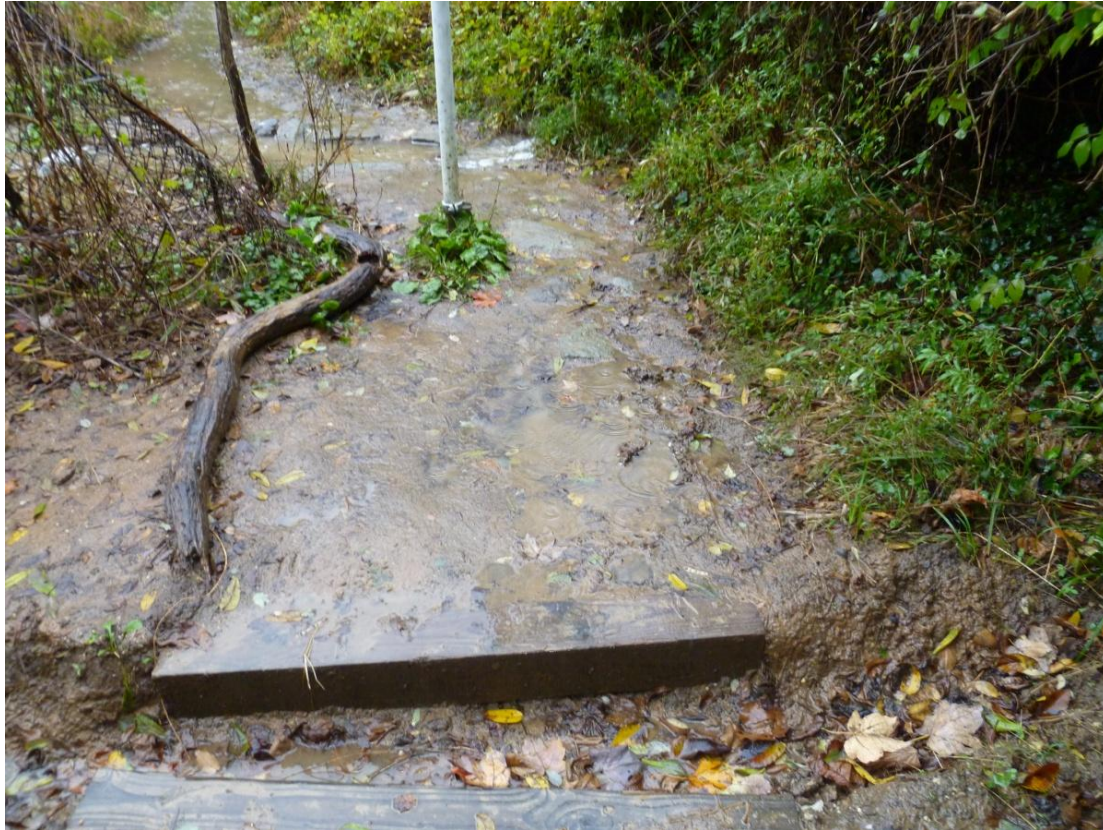
This picture shows two path crossings on the west side of the park at 10:35A for water that leaves the Naval Observatory/Building 52 parking lot. Water was collecting (but not flowing) in the 4X4 channel and flowing in the stone-lined channel to the south. The following picture shows the stone-lined channel where decreasing flow was observed/measured from 1.05 to 0.36 cfs (five measurements made 10:44-11:54A).

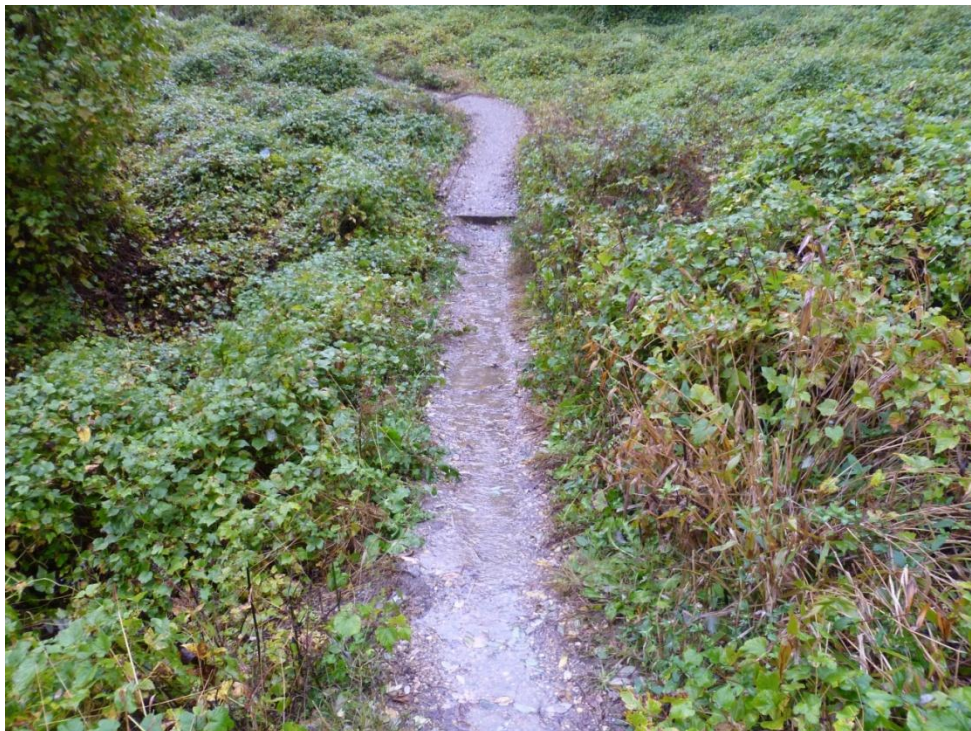
This photo shows the 30 inch headwater discharge of the Dumbarton Oaks stream (10:36A). Numerous flow measurements ranged from 0.253 to 4.47 cfs (the blower was on during the entire measurement period 10:53-11:31A). The 18 inch headwaters pipe was unknown at this time but is located on the south side of the stream (to the right in this photo) across from the vine-covered fence. The following picture (10:36A) shows some water on the trail to the south of the 30-inch pipe.

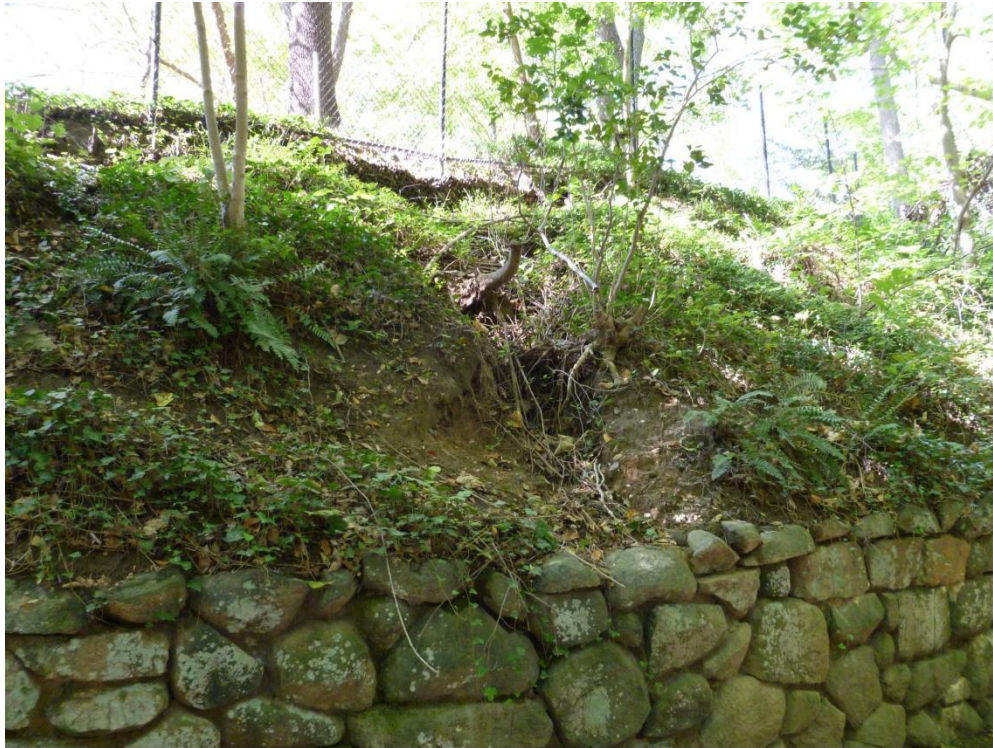
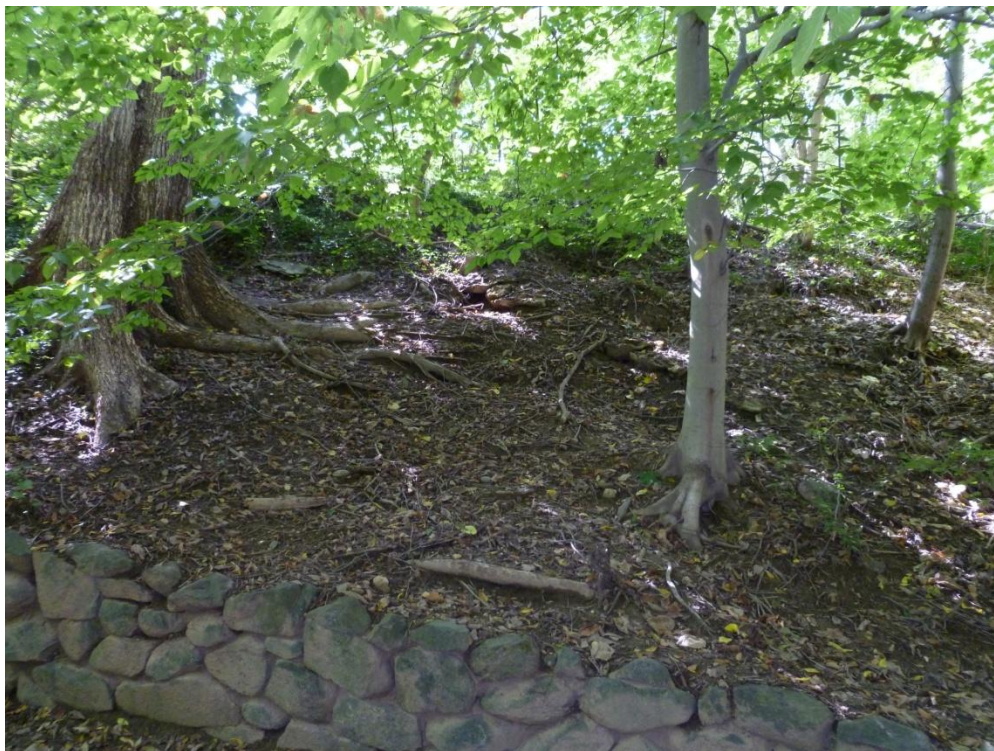
The top photo is a second photo of the same erosional area with vegetation (10-6-2011). The bottom photo shows another eroded slope including the Iris Path stones now visible.

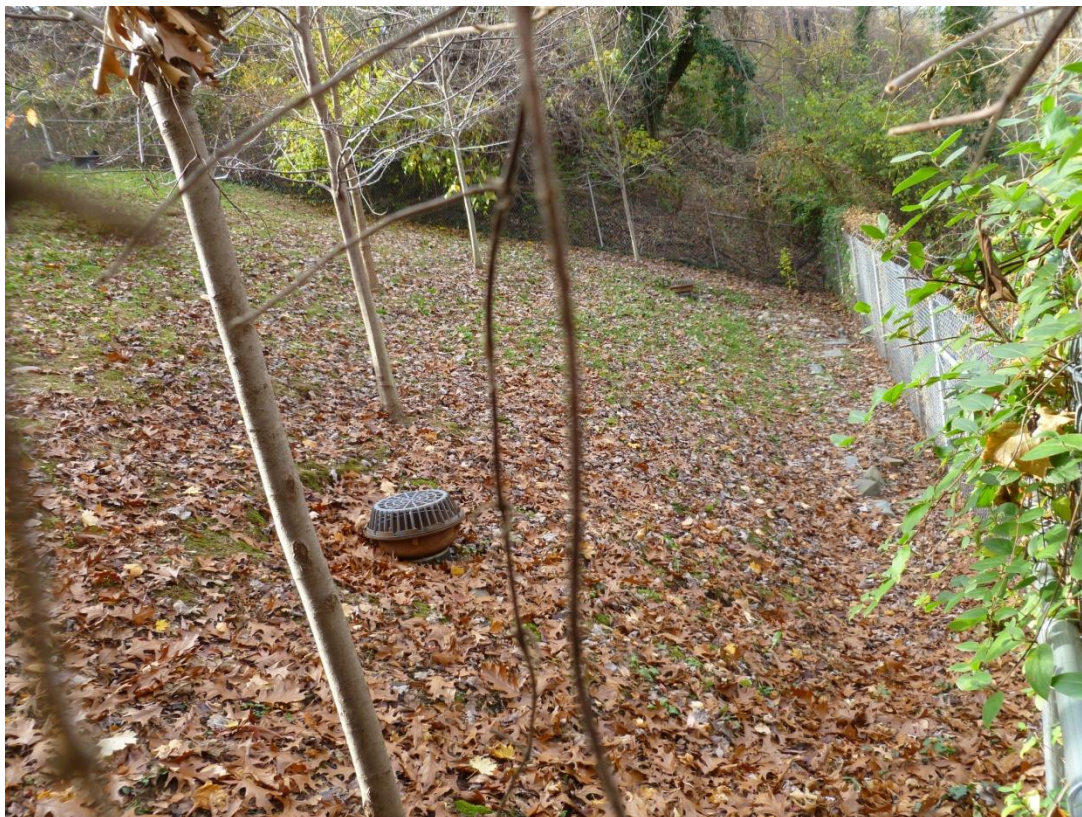
Picture (above) of the Gardeners Lodge east and west overflow caps of the stormwater infiltration piping that is located uphill of the bamboo forest adjacent to Clapper Bridge Falls. Note that the west end is lower in elevation than the east end. The following picture shows the rock fill on the west end used to return the eroded grade back up to the fence bottom.

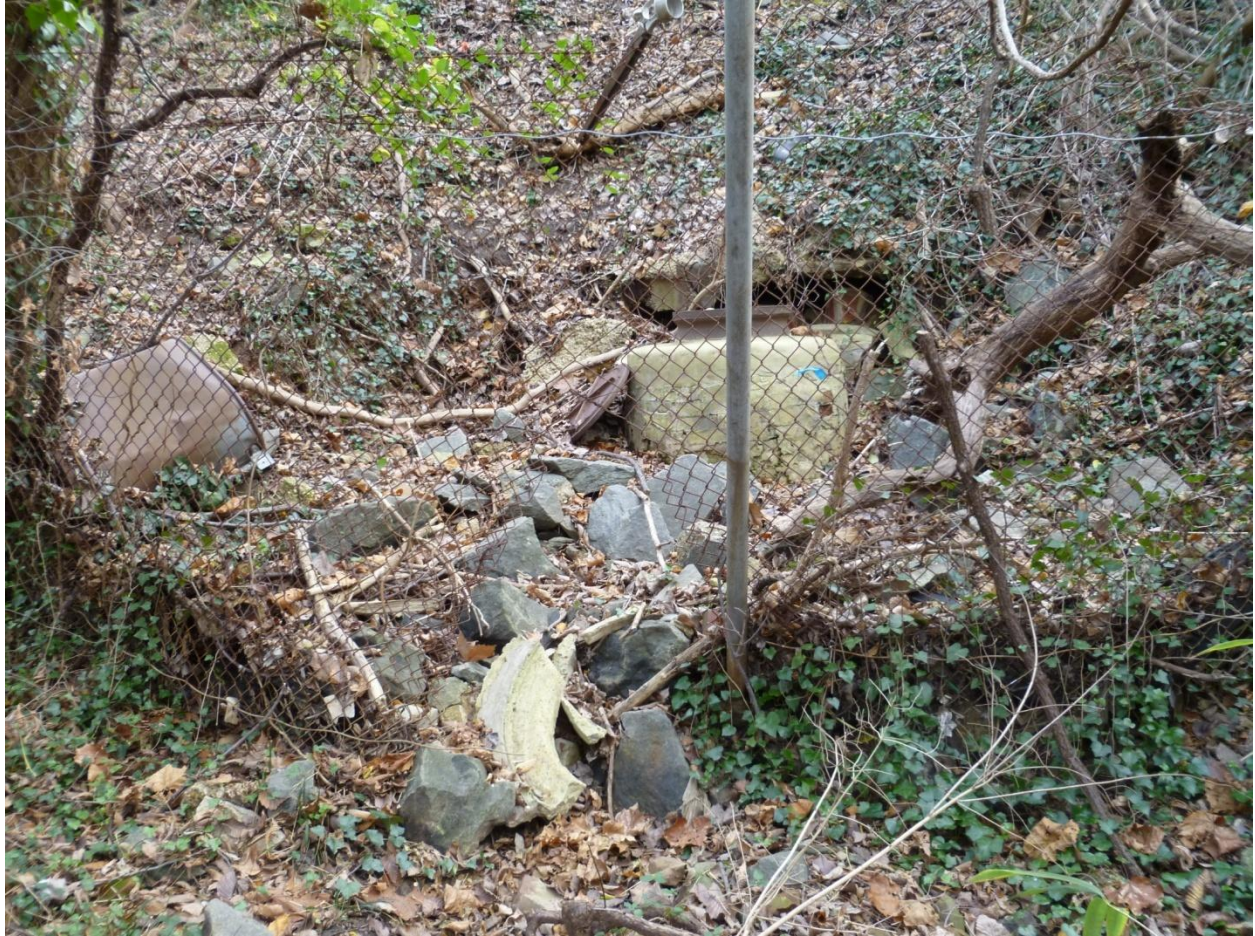
Sewer manhole located down slope of Jelleff. In spite of the solid waste debris used to minimize erosion, the soil upslope of the manhole has been eroded. If the round disc leaning against the manhole is the cover, this manhole may still be discharging into the park, i.e. this cover may not be bolted down to prevent discharge. (11-20-2011 photo)
