# Dumbarton Oaks Park Hydrologic Analysis Update, September-November 2011

By Zoe Kulakowski  
Geological Society of America-GeoCorps™ America  
Geoscientist-In-Park  
December 2011

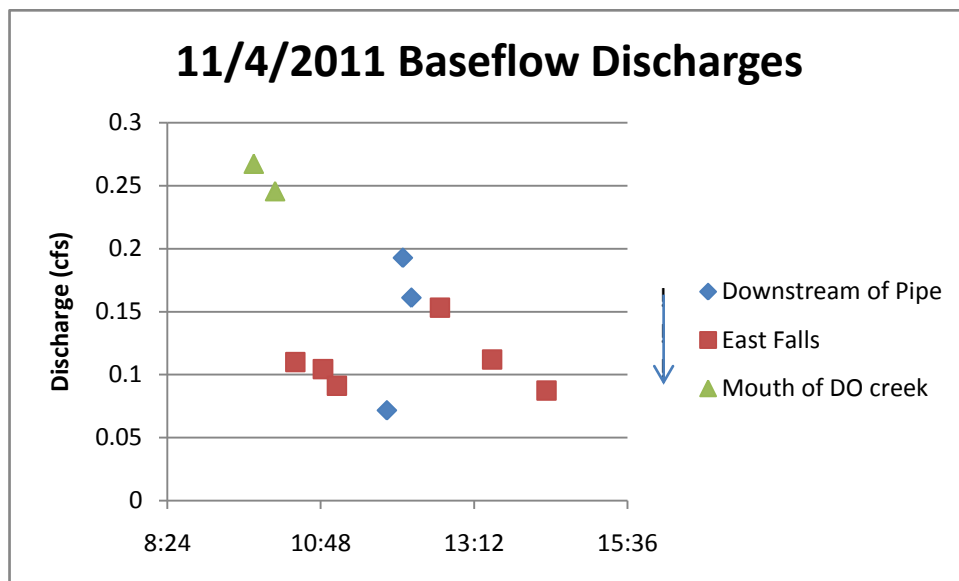
Figure 17: 11/4/2011 Dumbarton Oaks Park Baseflow Discharges

Stream baseflow is the groundwater contribution to flow, but for the Dumbarton Oaks stream it includes the flow surges of unknown sources. Flow measurements were made along several locations of the Dumbarton Oaks stream on November 4, 2011 to evaluate the stream for baseflow conditions and the possibility of rising/falling discharge along the stream channel. Stream discharges can increase or decrease along their stream course due to recharge coming

in from or going out to groundwater as well as receiving/losing discharge from/to underground piping. No precipitation had occurred since the “trace” amount on October 31, 2011, eliminating the potential influence of stormwater runoff. The East Falls stage (surface water elevation) remained constant at 0.66 feet during the 5-hour measurement period. Discharge results are presented in Figure 17 and summarized in Table 3. Note the East Falls discharge range of 0.0874-0.153 cfs for one stage (0.66’). The arrow on Figure 17 shows the direction of surface water flow for the three stations from upstream to downstream.

Flow in the stream starts at the 30 inch-discharge pipe located in the southwestern part of Dumbarton Oaks Park. Flow discharging from this pipe is variable with flow surges observed following the sound of a blower. The depth of water exiting this pipe was 0.05 feet; too shallow for a velocity measurement, but existing data can be used as a rough estimate. Velocity measurements for this pipe have ranged from 0.32 to 6.92 feet per second (ft/s) with an average of 3.43 ft/s. Discharge calculated with this average velocity and the 0.05 foot water depth is 0.08 cubic feet per second (cfs). (The sound of the blower coming on was heard while leaving the area.) The water depth on the discharge pad was also too shallow for measurement so a location was selected approximately 150 feet downstream (but up stream of the western-most Jungle Fall structure). This location (DS30”) was downstream of both the 30-inch and 18-inch Headwaters pipe discharge locations. The three discharge measurements along this section of the stream ranged from 0.07-0.19 cfs (including two measurements of the flow surge) with an average of 0.14 cfs. If the 18-inch Headwaters pipe was flowing at this time, it did not add significant flow.

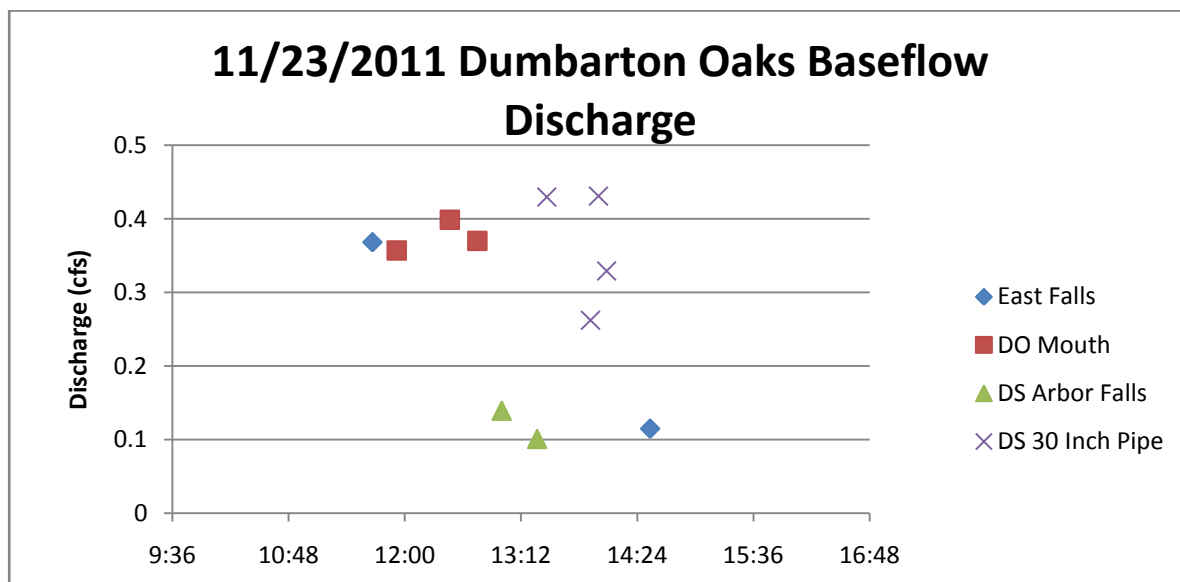
On November 23, 2011, similar measurements were made the day following 0.41 inches of rain, adding a new station on the downstream side of Arbor Falls. Figure 18 does not indicate any significant groundwater influence on the flow between East Falls and the mouth with Rock Creek. Both flow measurements at the downstream Arbor Falls transect had a section with visible flow, but the water depth was too shallow to measure and these discharges are on the low side. The last discharge measurement of the day at East Falls reflects declining discharge and is the probable lowest measurable discharge at East Falls at this stage (0.77) as East Falls is essentially a pool at the staff gage location. The "DS 30 Inch Pipe" station is located about 300 feet (90 meters) southeast of the 30" headwaters pipe (also downstream of the 18 inch headwaters pipe). The four measurements show variable discharge, but the average discharge (0.363 cfs) agrees with the initial East Falls (0.368) and the Dumbarton Oaks stream mouth discharges (average 0.375 cfs). Since the average discharge at the downstream 30 inch pipe location agrees with East Falls and the mouth with Rock Creek, and there are no known additional flow inputs, this is probably equal to the discharge from the 30 inch pipe. However, the depth of water in the 30 inch pipe was 0.5 inch and using the average velocity, 1.37 ft/s plugged into an online flow calculator, this gives a discharge of only 0.0687 cfs. (The average velocity was for a water depth of 0.1' and because velocity declines with water depth, this velocity gives a high end estimate for a 0.5 inch water depth.) Velocities typically vary and average velocities are used for calculating discharges. Velocity variation applies to the Dumbarton Oaks stream, but the velocity data for the 30" pipe does not represent the pipe center velocity range because the FlowTracker makes the measurement four inches from the acoustic transmitter. Figure 19 shows the discharge

Figure 18: 11/23/2011 Dumbarton Oaks Park Baseflow Discharges – the initial East Falls, Dumbarton Oaks mouth, and Downstream 30" pipe discharges are similar and likely represent the concurrent 30" Pipe discharge.

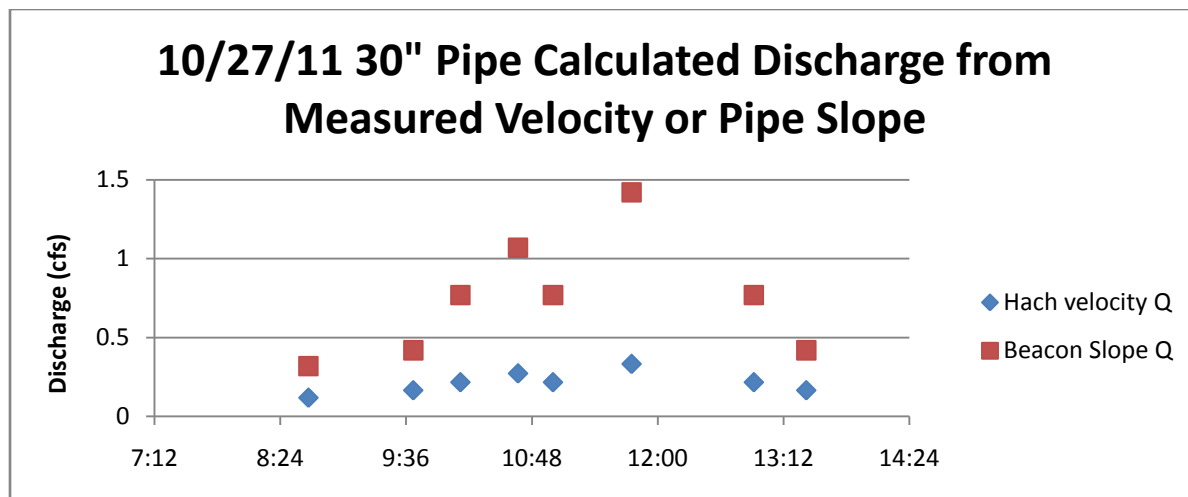
differences calculated from the 10/27/2011 30" pipe water depths and the average SonTek FlowTracker velocities (for each specific depth) or the pipe slope using an online flow calculator (Hach or Beacon). The pipe slope-based discharges show greater variation with pipe water depth increase than the velocity-based discharges. Figure 20 compares the discharge differences relative to 10/29/2011 water depth at the 30" pipe for: (1) average SonTek, (2) high SonTek, (3) expected discharge from a pipe with a 3 percent slope, and (4) approximately concurrent East Falls measured discharges. Average discharges are used to describe variable flows. The high discharges reflect the highest SonTek discharge recorded for that specific depth. The 3 percent slope is used for comparison because it is close to the 0.026 slope measured at the pipe and it is the common engineering design slope to maintain flow velocities for self-cleaning of leaves and debris. The East Falls peak discharge relative to the 30" pipe 0.4' water depth was missed due to the one hour travel time/photo documentation of stream conditions on 10/29/2011. The Figures 19 and 20 discharge discrepancies apply only to the 30" pipe measurements; measurements at other locations appear valid and agree with typical variations.

Figure 19: 10/27/11 30" Pipe Calculated Discharge from Measured Velocity or Pipe Slope - The pipe slope-based discharges (correctly) show greater variation with pipe water depth increase than the FlowTracker velocity-based discharges.

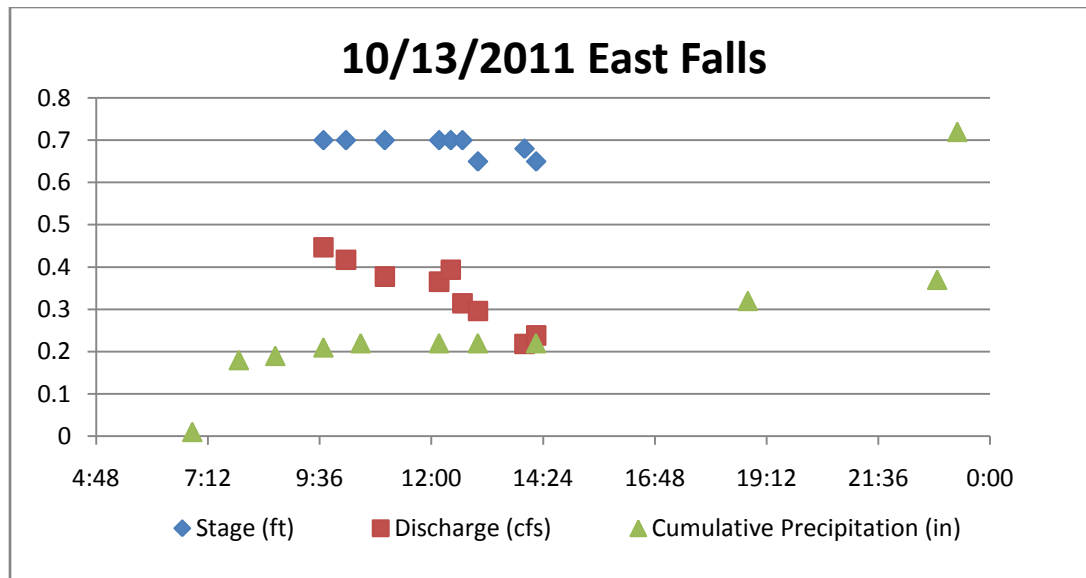
Figure 21: 10/13/2011 East Falls Stage, Discharge, and Cumulative Precipitation

Precipitation on 10/12 and 13/2011 included soil infiltration, and at least for the daylight hours did not include flowing volunteer streams. Runoff occurs when the rainfall intensity exceeds the infiltration capacity of the soil. Figure 21 shows the hydrograph and cumulative precipitation for 10/13/2011. The 10/13/2011 peak hour of precipitation ended at 7:52 (0.17"), but the data show constant stage and declining discharges, indicating data collection missed the peak discharge as stage had already dropped to baseflow at the time of first measurement at 9:41.

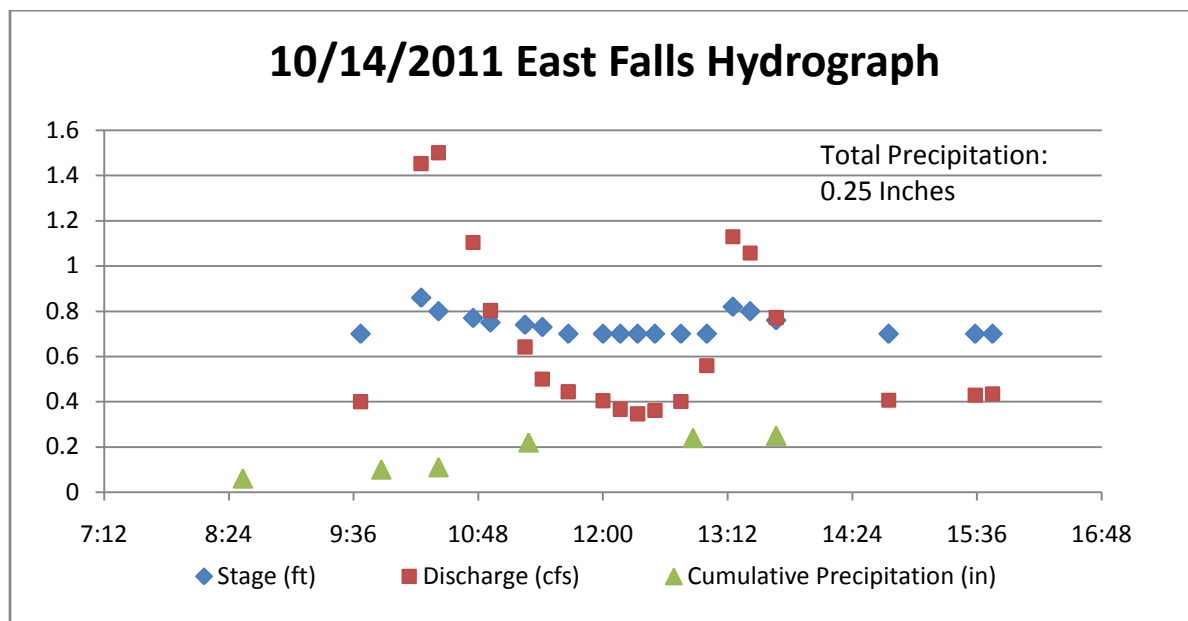
Complete soil saturation may have occurred the evening of 10/13/2011 from the heavy rain of 0.50 inches. Evidence of higher stage was observed the following morning (absence of water line marker, removal of all fallen leaves along the stream flood plain, and new snags of branches, twigs and leaves). The volunteer streams were flowing with each rain event on 10/14/2011 and saturated soil conditions have been assumed. Pictures were taken of the volunteer flow entering upstream of East Falls. The flow was very turbid, with turbidity declining as each rainfall event ended. Stream water clarity declines as discharge increases from storm water runoff. Figure 22 shows the East Falls stream hydrograph for stage and discharge with cumulative precipitation on 10/14/2011. Two stage/discharge peaks were captured with peak discharge occurring 33 and 23 minutes, respectively after precipitation. The first peak of 10/14/2011 was the only hydrograph curve with enough data to visually determine the inflection point (defined as the time that the runoff portion of the hydrograph ended and stream discharge source became predominantly storage, interception and groundwater recharge). This time is 11:25, an hour after the discharge peaked. Figure 22 also shows the rapid rise and fall of stage and that the entire event is over in 2 hours.

Figure 22: 10/14/2011 East Falls Hydrograph: shows the stage and discharge of two runoff peaks.

The data for 10/14/2011 captured peak flow and two complete rise/recession curves. The first peak precipitation occurred at 9:52 (0.11") with peak discharge (1.506 cfs) following at 10:25, giving a time of concentration of 33 minutes. The second peak precipitation occurred at 11:17 (0.11") with peak discharge (1.13 cfs) following at 13:50, giving a time of concentration of 1 hour and 58 minutes. Additional data is needed to understand why the second peak has a lower discharge and a longer Tc for the same amount of precipitation. Possibilities include additional infiltration (reducing runoff volume) and less water in storage available for release.

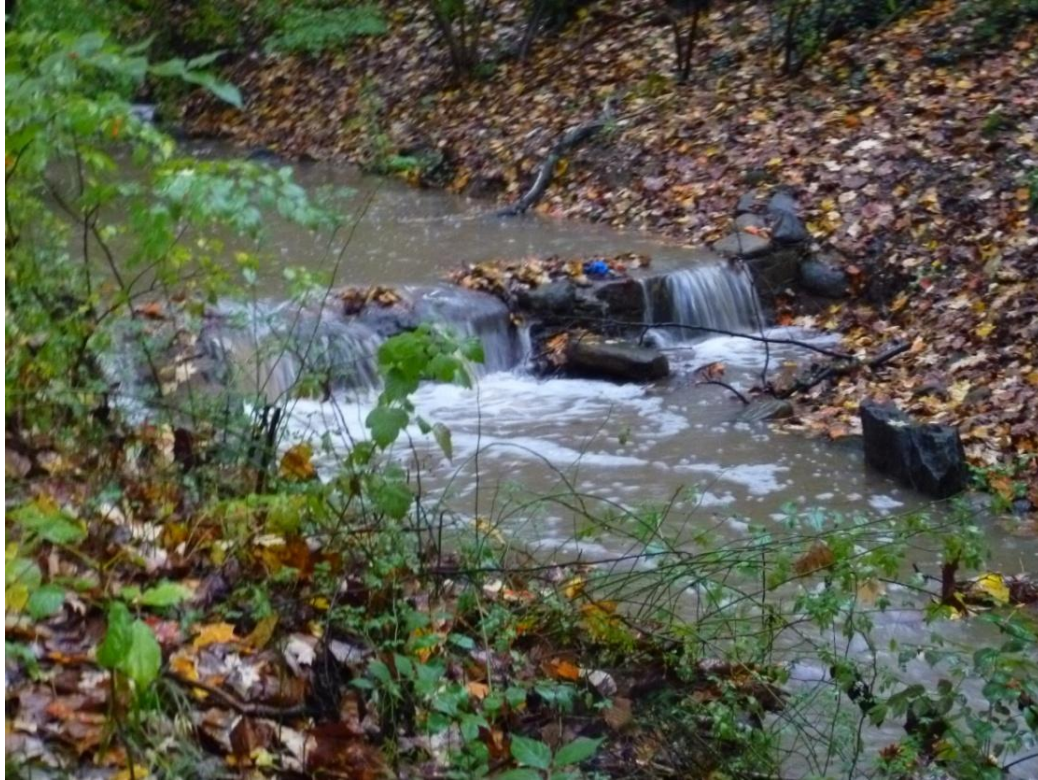
Three Bridge Falls (E) at 10:01A – water volume exceeds the capacity on the south side of the structure.

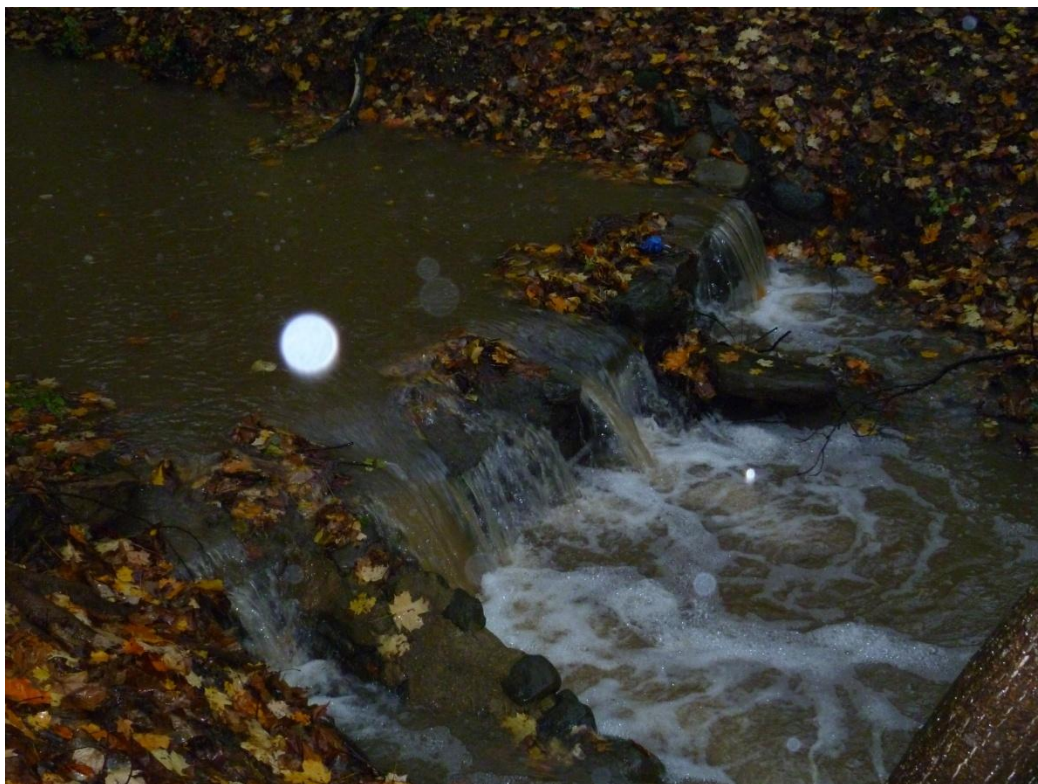
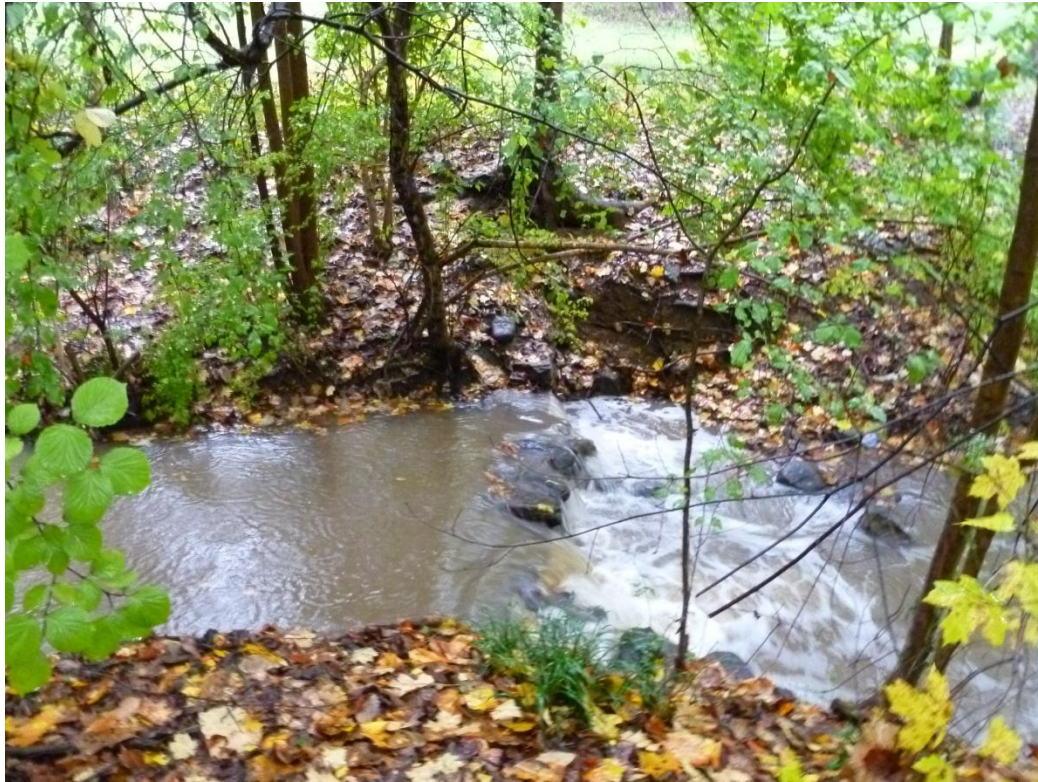
Three Bridge Falls (M) opposite Forsythia Way at 10:01A – water volume exceeds the capacity on both sides of the fall structure. A more detailed photo taken at 10:02A follows below.

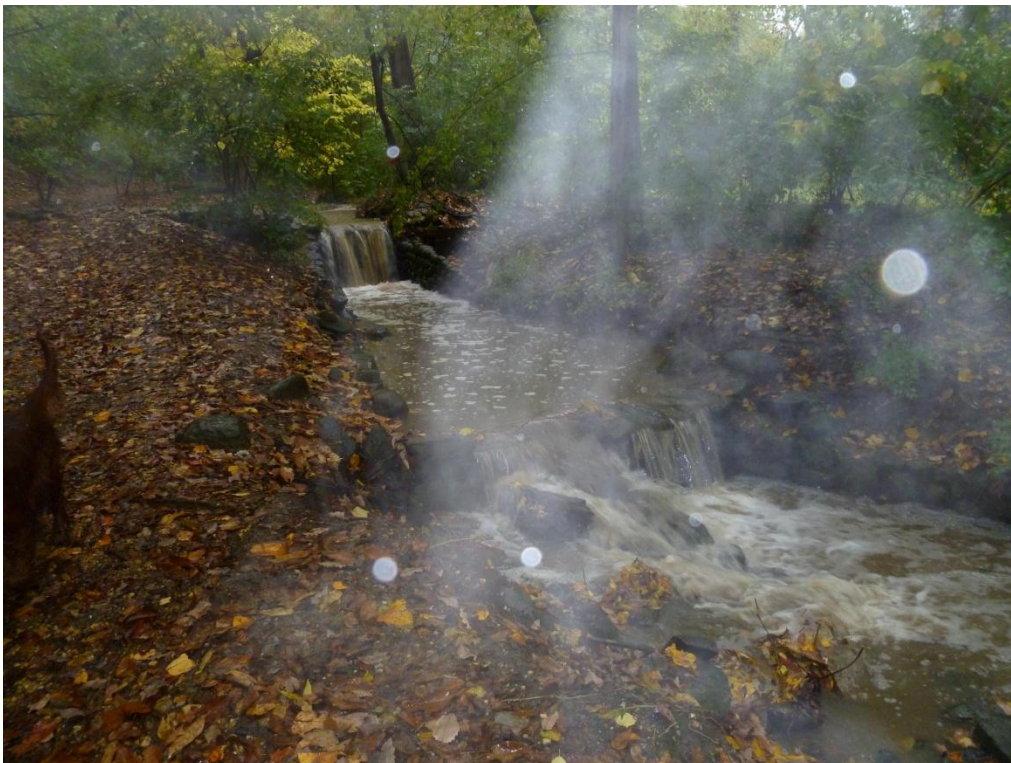
In spite of the humidity/raindrop compromised photo above, it is clear that the middle Three Sisters Fall has flow leaving the south side channel (10:07A). The Three Sisters Falls (W) handles the discharge but has past erosion from a volunteer tributary outside its north wing wall. Both waterfalls are below.

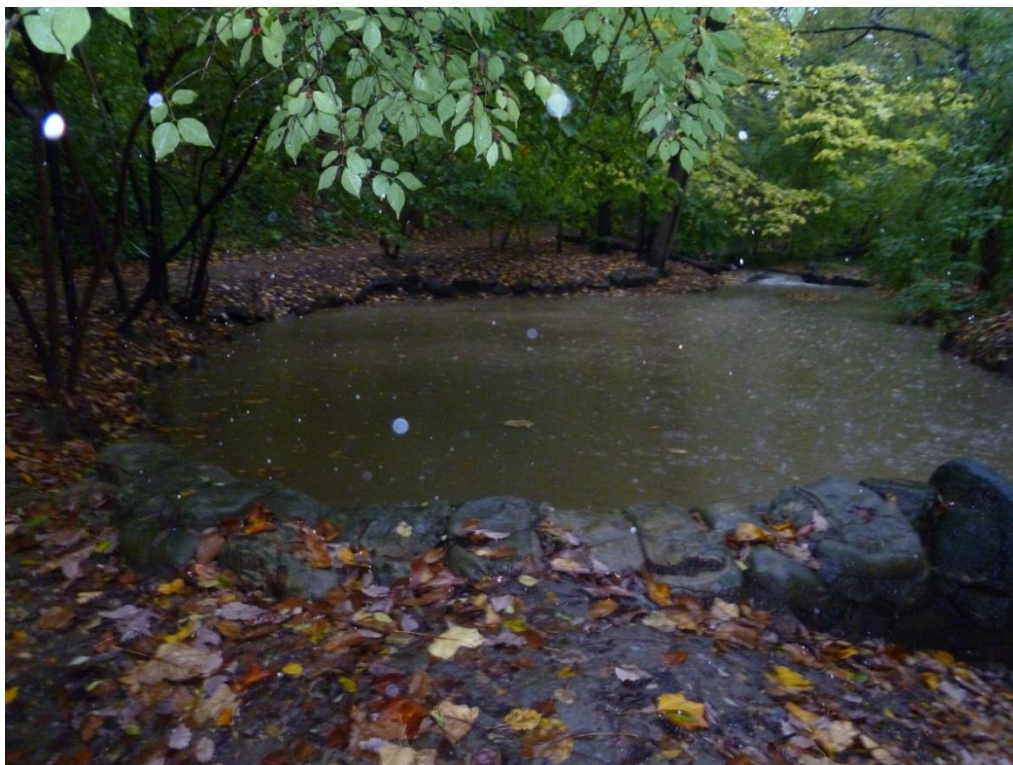
(Above photo) Laurel Pool at 10:08A is full and providing water storage. The eroded pool banks are not visible. Note that the incoming flow to Laurel Pool takes the shortest flow path along the north shore to the water fall. This is the cause of the north bank erosion. Any pool rehabilitation to fix this situation will require a hardened north bank (boulders or a stone wall). The following picture shows West Laurel Falls at 10:12A discharging into Laurel Pool (no capacity problems at this volume). The log damming the stream channel serves to increase creek storage by causing the upstream water to pool, but needs to be removed for higher flows. The volunteer tributary from the Farm Track drainage path was actively discharging on the north side of the north wing wall.

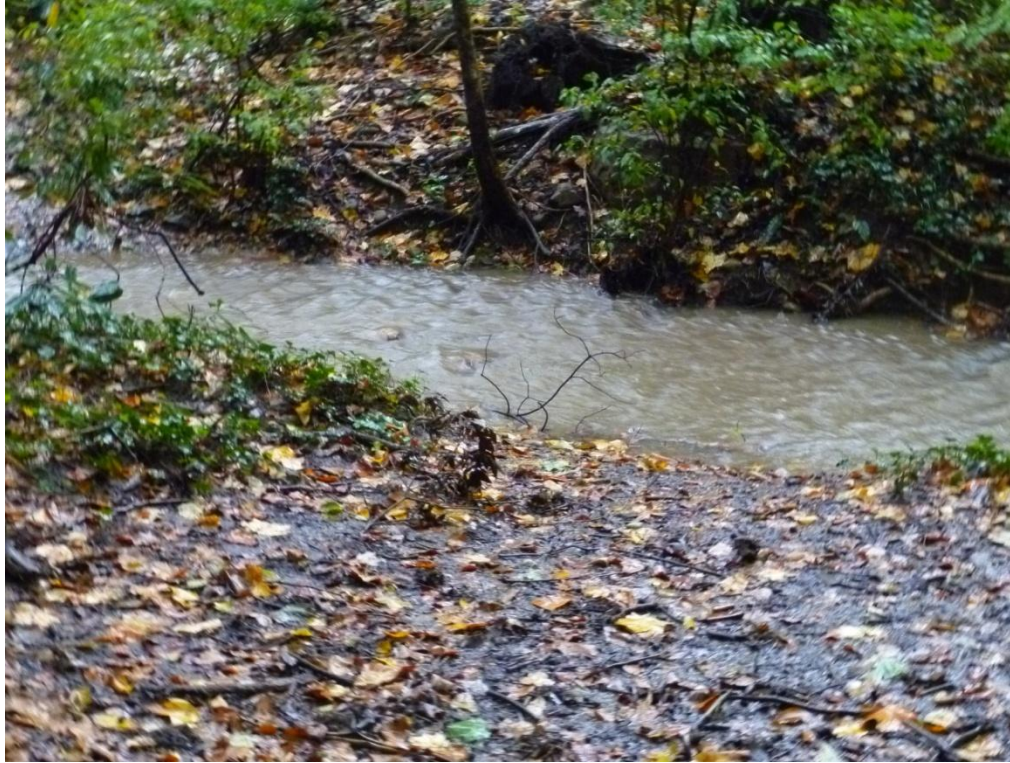
The stream channel (10:17A) between the Spring Grotto/Pebble Path and Arbor Falls has migrated north and is eroding the north bank exposing the roots of the remaining trees and plants. Bulb plantings on the top of the north bank are being eroded with every rain event. Alternatives to fix this situation include (1) the installation of a rock wall similar to those used by Beatrix Farrand for high velocity stream sections (2) the removal of sediment, followed by the addition of cobbles to create a wide, gently-sloping cobble-lined stream course, and (3) the armoring of the north bank with boulders to force the flow south. The channel is steep enough in this section to concentrate the flow into a narrow width (increasing the flow velocities) and even the armoring option should include a widening of the stream base to increase friction and slow the velocity. The following photo (10:18A) shows the upstream section and the beginning of the eroded section.

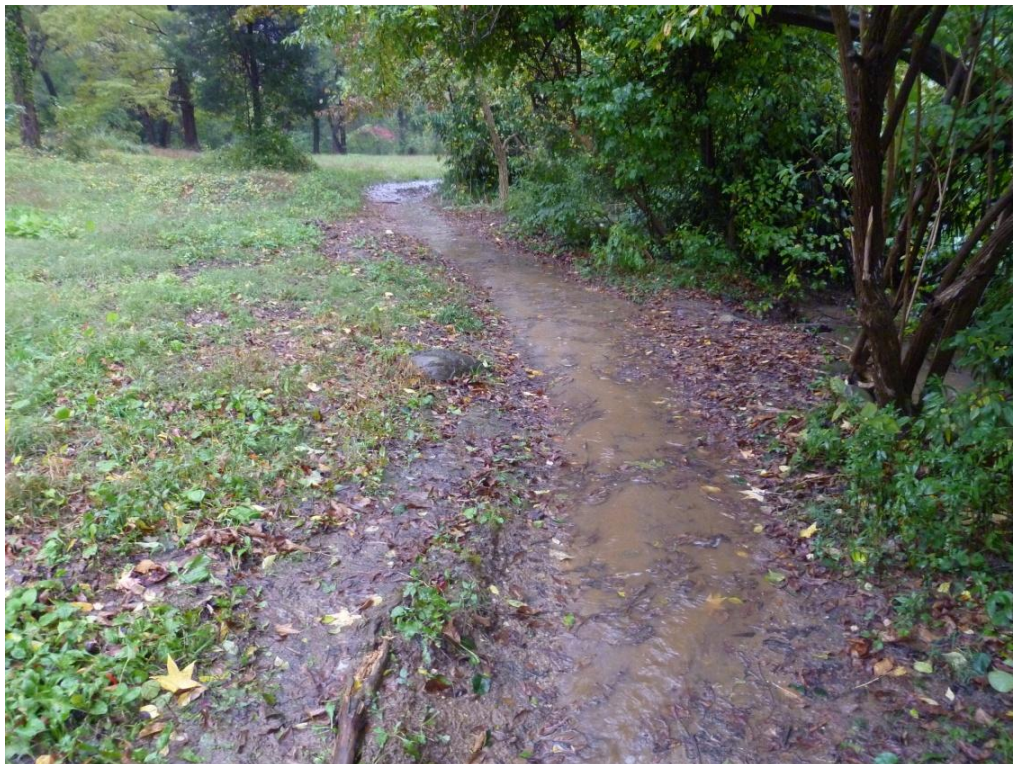
(Above photo) Looking east towards Clapper Bridge Falls, this picture (10:29A) shows that water follows the park trails and is transporting turbid water. The following pictures (10:31A and 10:32A) show the same trail to the west (but looking east and west, respectively).

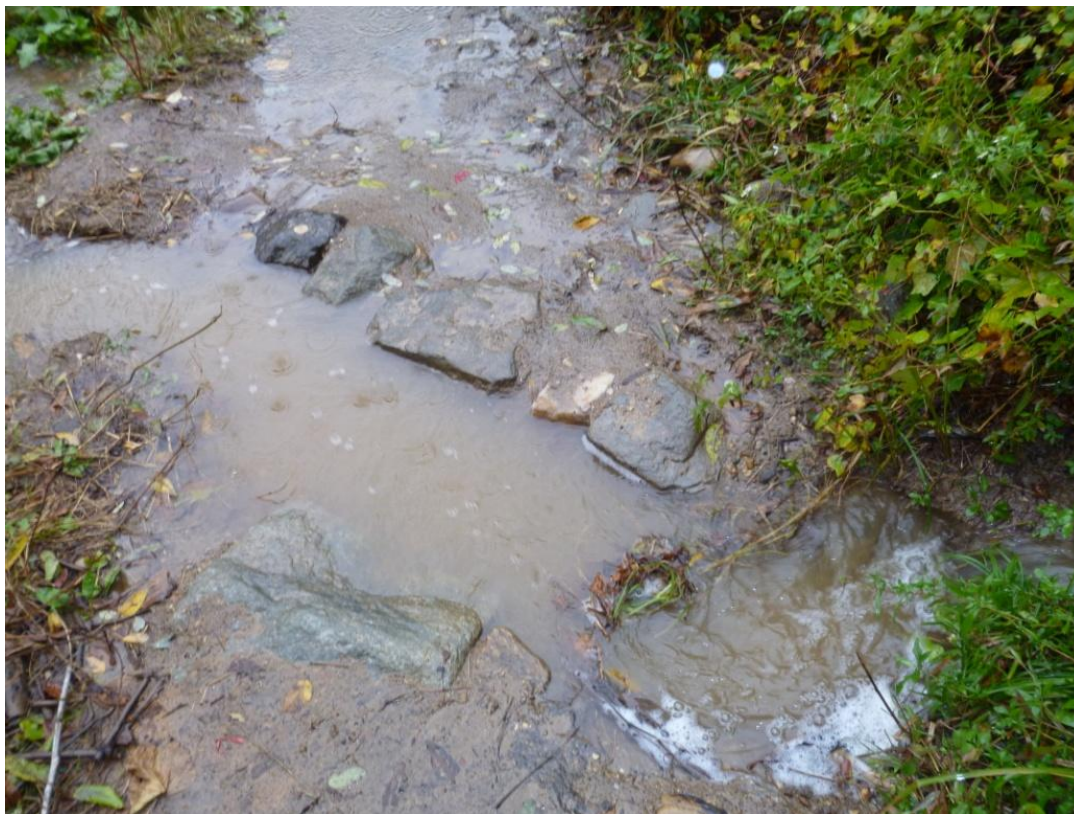
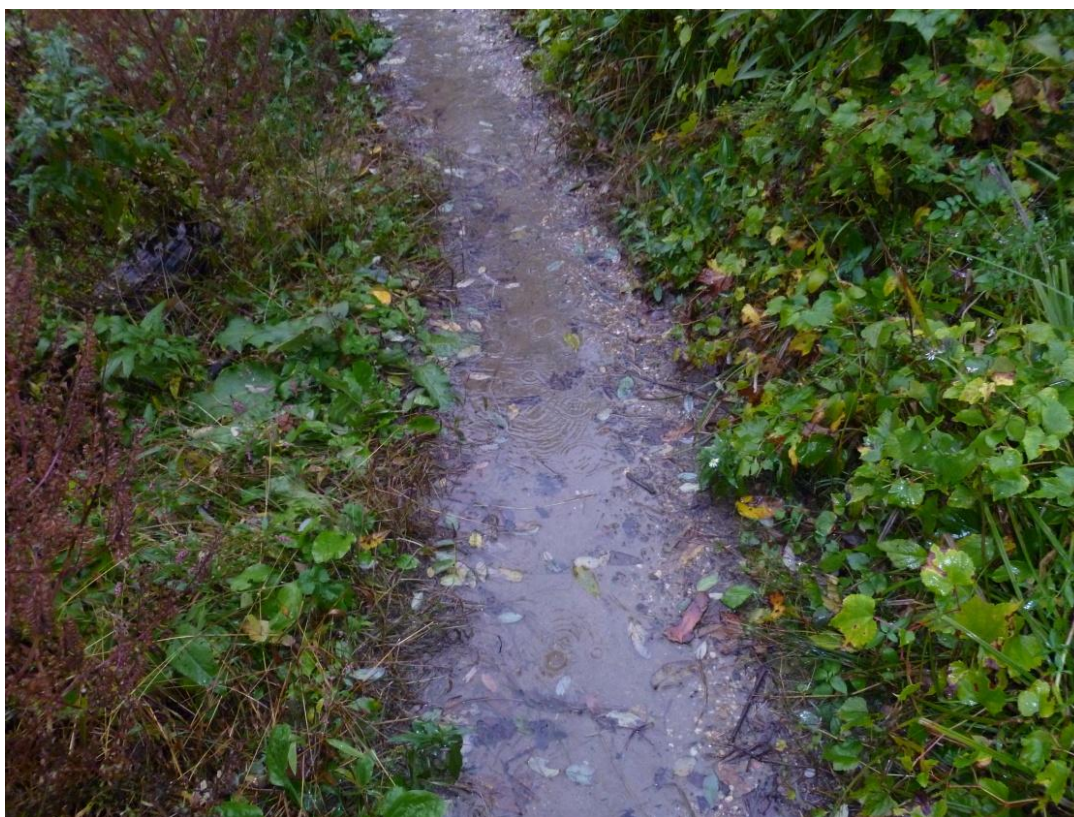
This picture shows two path crossings on the west side of the park at 10:35A for water that leaves the Naval Observatory/Building 52 parking lot. Water was collecting (but not flowing) in the 4X4 channel and flowing in the stone-lined channel to the south. The following picture shows the stone-lined channel where decreasing flow was observed/measured from 1.05 to 0.36 cfs (five measurements made 10:44-11:54A).

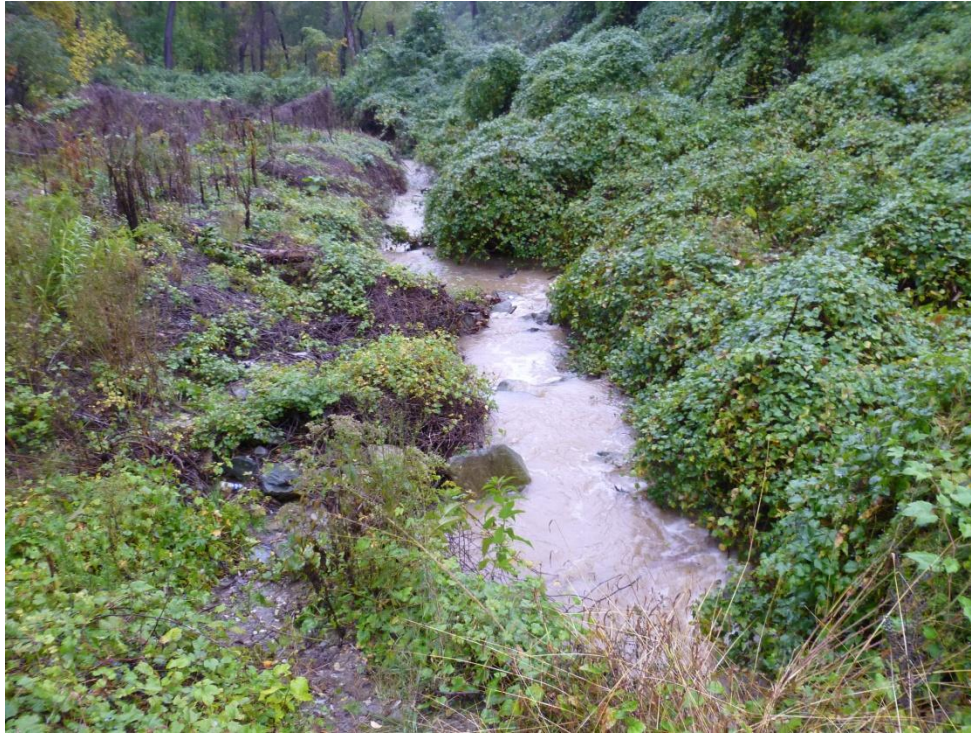
This picture shows water on the trail looking to the south (10:35A).

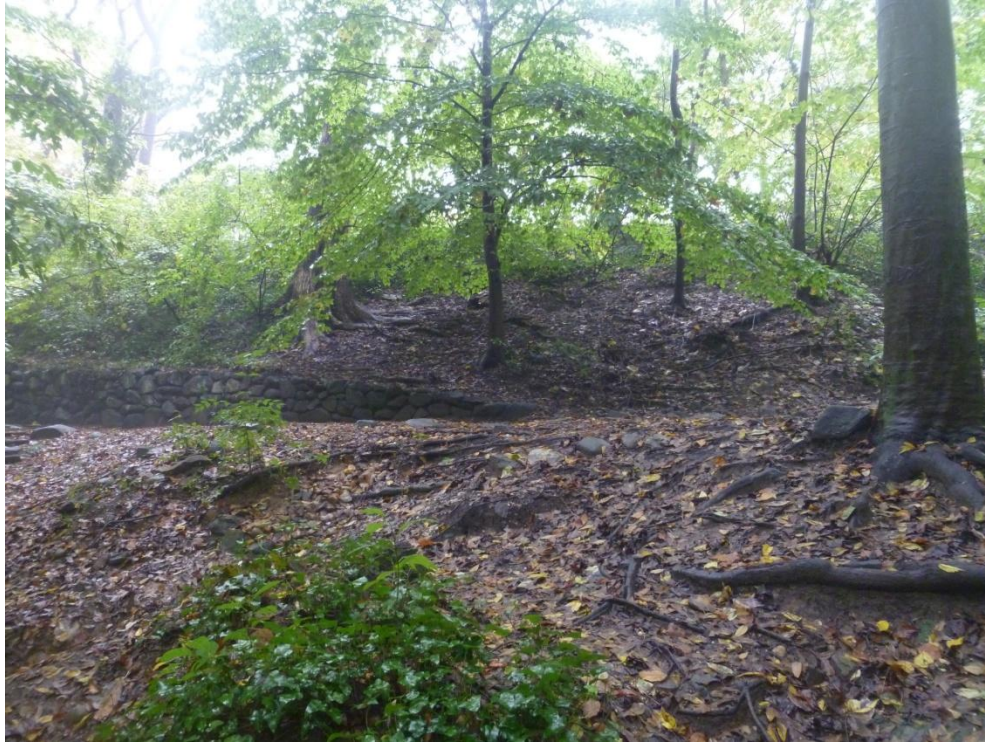
The top photo is a second photo of the same erosional area with vegetation (10-6-2011). The bottom photo shows another eroded slope including the Iris Path stones now visible.

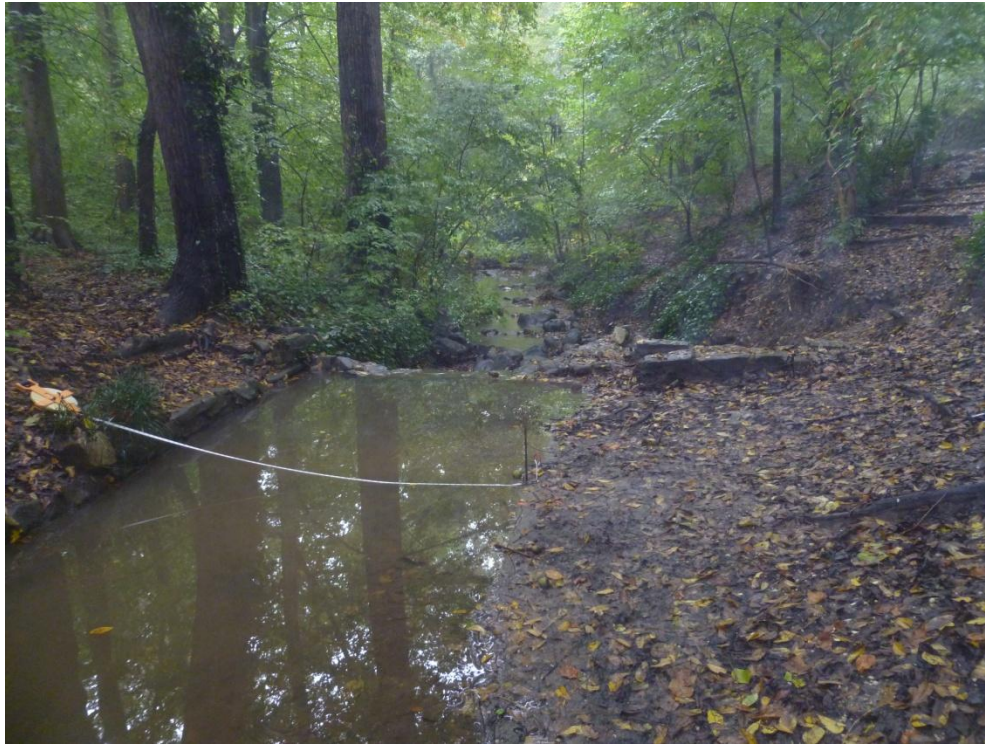
Looking east from East Falls and showing the erosion that created higher elevation “ivy islands” between the runoff flow pathways.

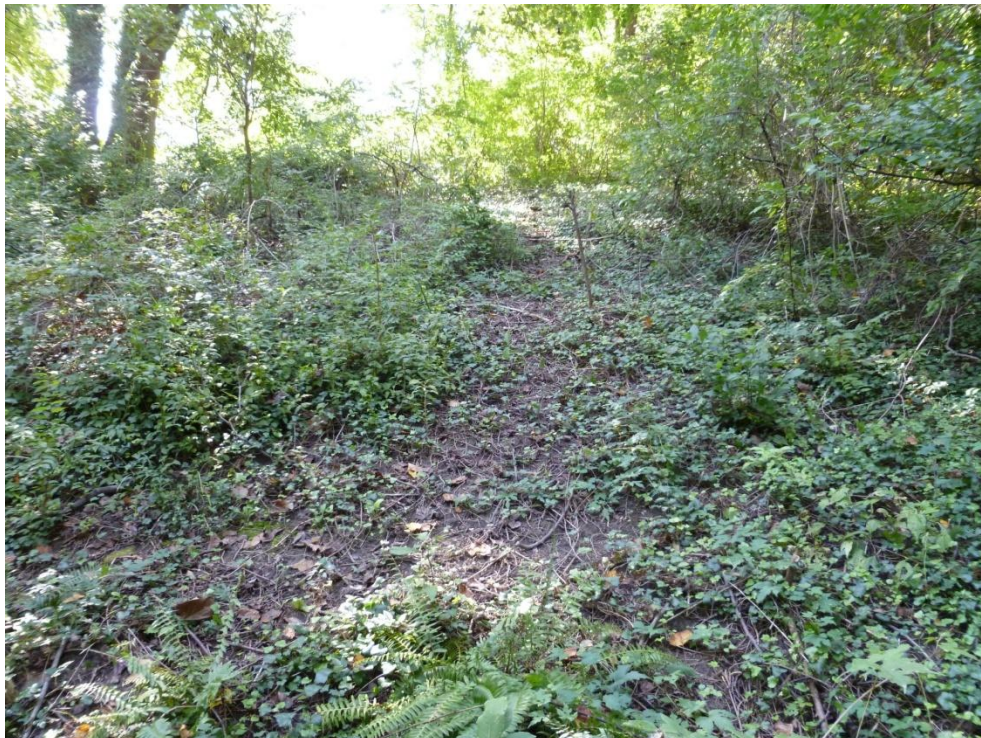
The concrete sewer pipe is exposed because runoff collects on the stream path, flows east to the low spot at the base of the south slope with Dumbarton Oaks and joins flow from Dumbarton Oaks during higher rain events. The high flows removed soil that originally covered the sanitary sewer pipe.

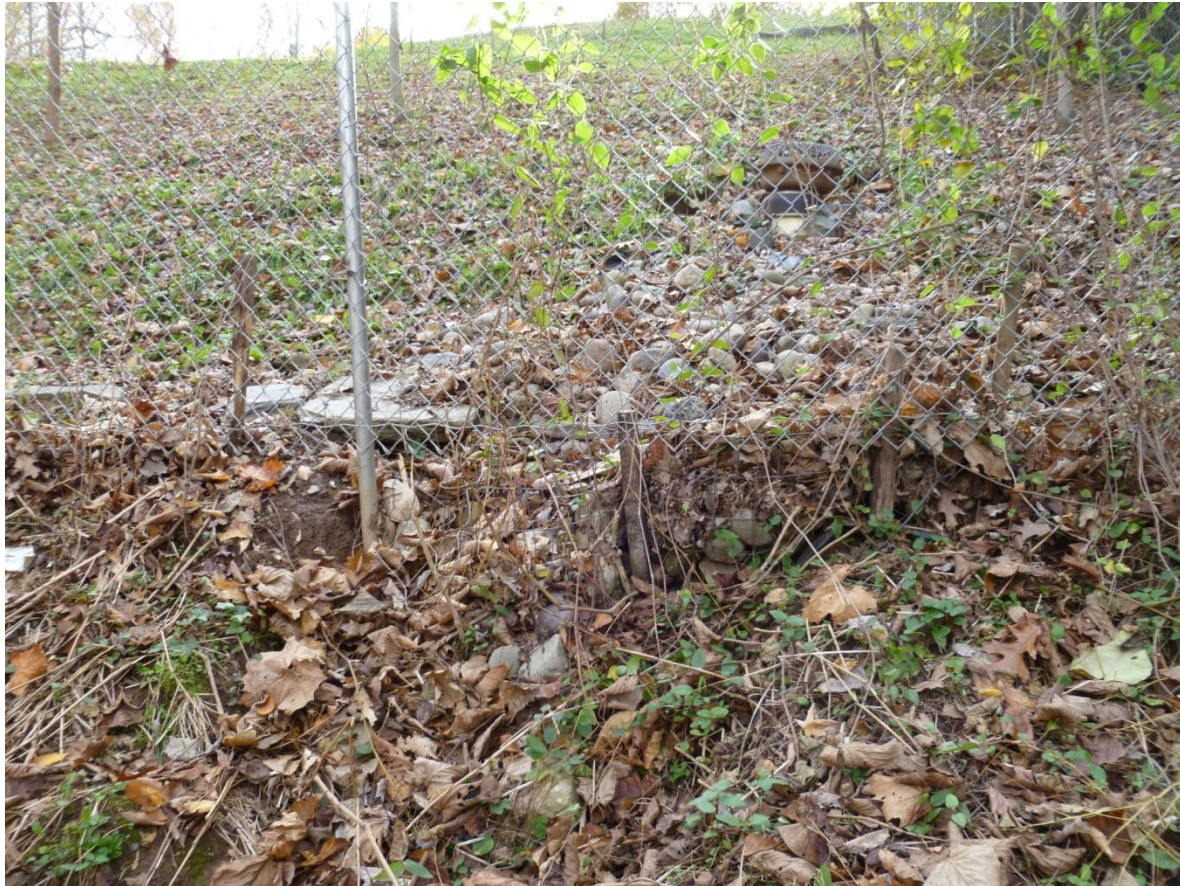
Picture (above) of the Gardeners Lodge east and west overflow caps of the stormwater infiltration piping that is located uphill of the bamboo forest adjacent to Clapper Bridge Falls. Note that the west end is lower in elevation than the east end. The following picture shows the rock fill on the west end used to return the eroded grade back up to the fence bottom.

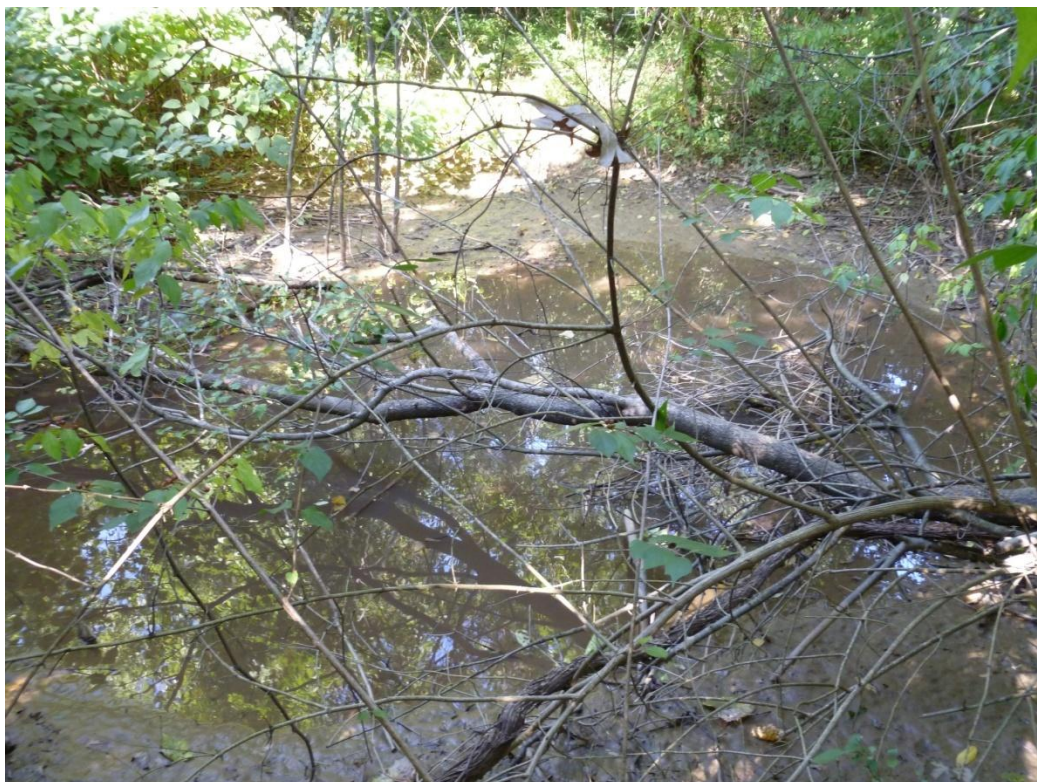
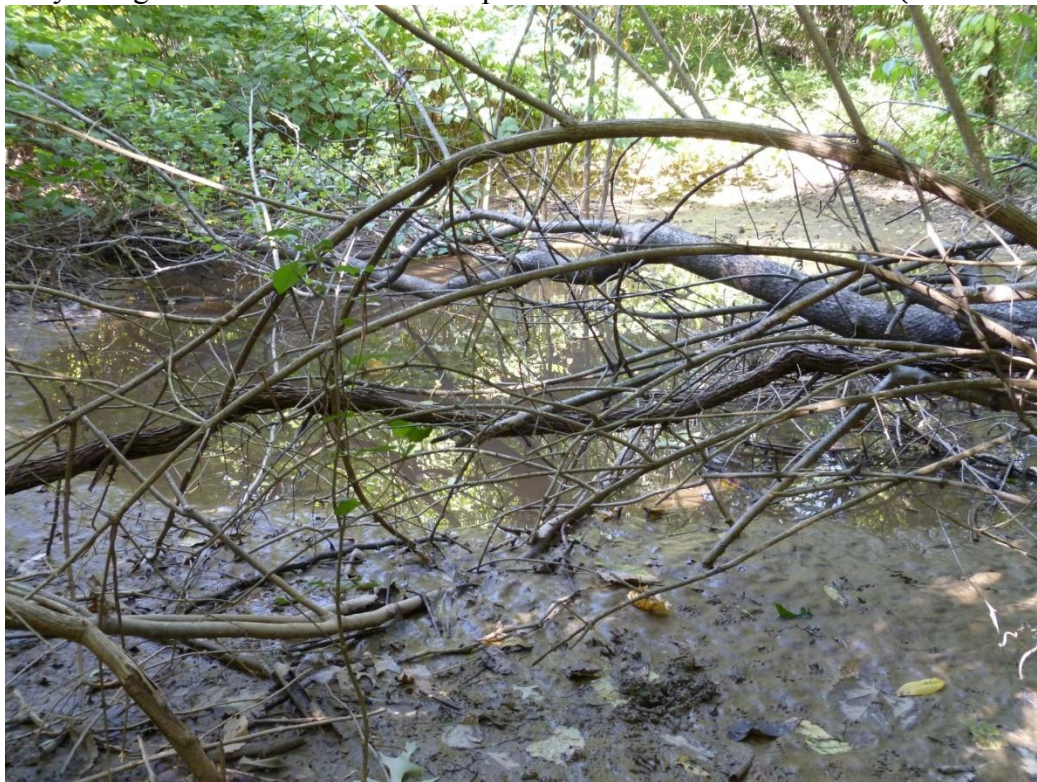
Above and below are photos of the overgrown 20 foot diameter stormwater pond located close to Whitehaven Street outside the Dumbarton Oaks Park. West and uphill of this pond is a porcelain berry overgrown area that has 6"X6" posts laid down to control flow. (10-6-2011)

3. The existing small 20-foot diameter storm water detention facility downhill of the Naval Observatory parking lot needs to be maintained, including repair of the overflow point that has a young gully. There also may be another “pond” in this area now over grown with porcelain berry upstream of this observed facility on the immediate opposite side of the trail (see GPS location #15). The potential additional “pond” includes posts installed on the ground to control the direction and level of flow draining to the 20-foot diameter pond. Redesign of this facility to retain and treat all runoff (including the heavy precipitation events) from the Naval Observatory parking lot (perhaps as a RSC winding down the slope) would be the best option for the Dumbarton Oaks Park. This area also has a minimum number of property owners (Federal and District of Columbia) and might be the most expedient off site runoff volume and turbidity source to reduce.

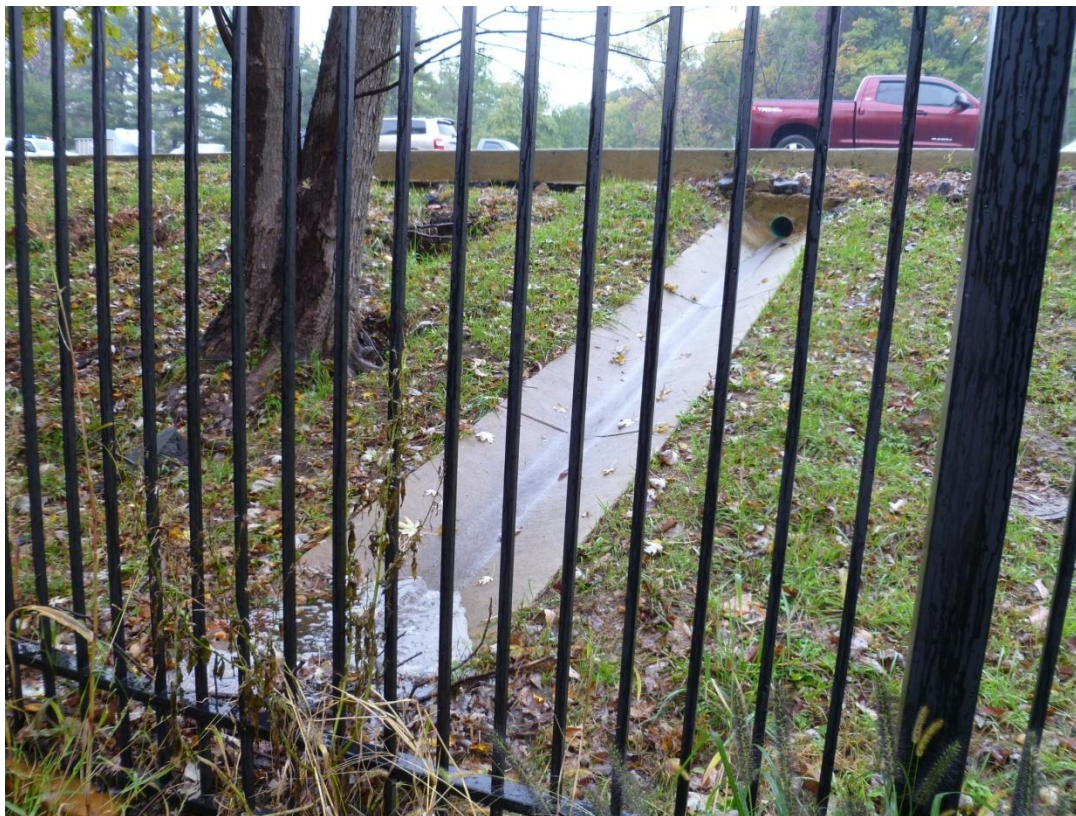
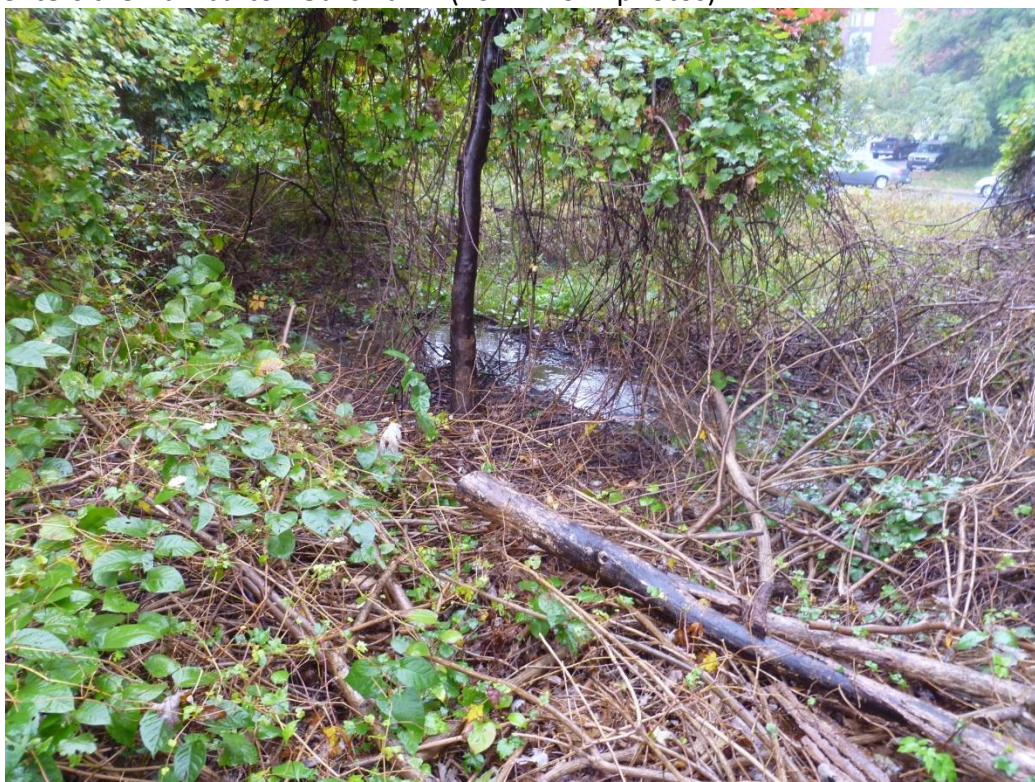
Drainage from the Naval Observatory Building 52 parking Lot enters the Federal Reservation 357, flows overland (picture below with Whitehaven Street in the background), and eventually enters the Dumbarton Oaks Park. (10-27-2011 photos)
