# Dumbarton Oaks Park Hydrologic Analysis Update, September-November 2011

By Zoe Kulakowski  
Geological Society of America-GeoCorps™ America  
Geoscientist-In-Park  
December 2011

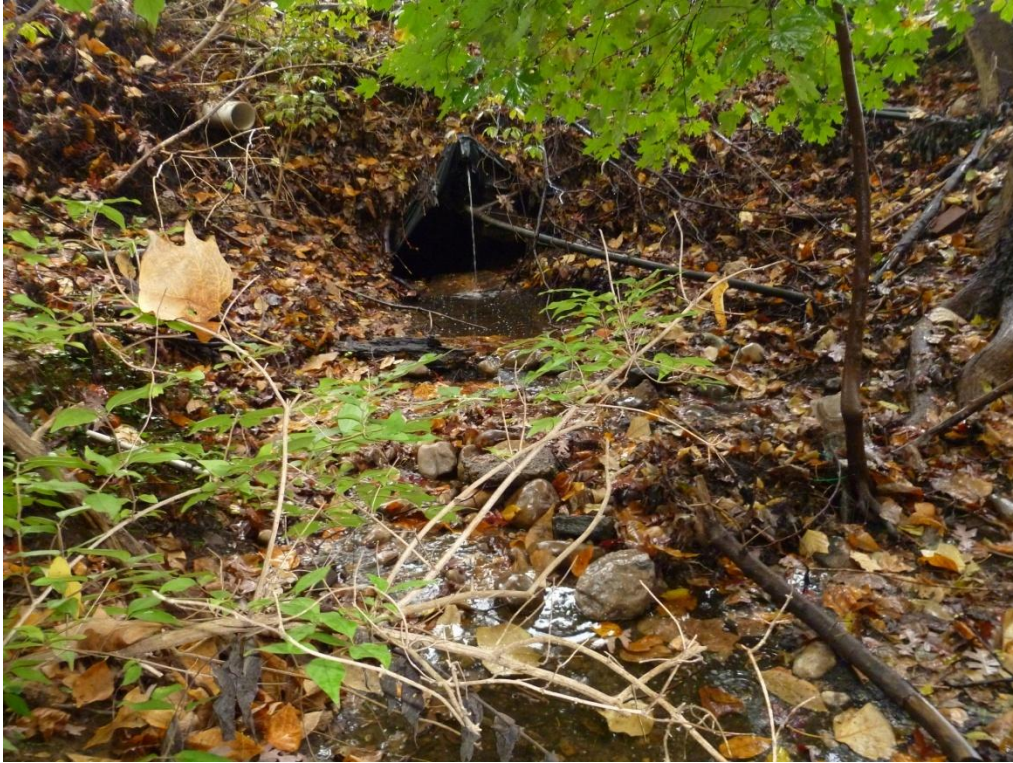
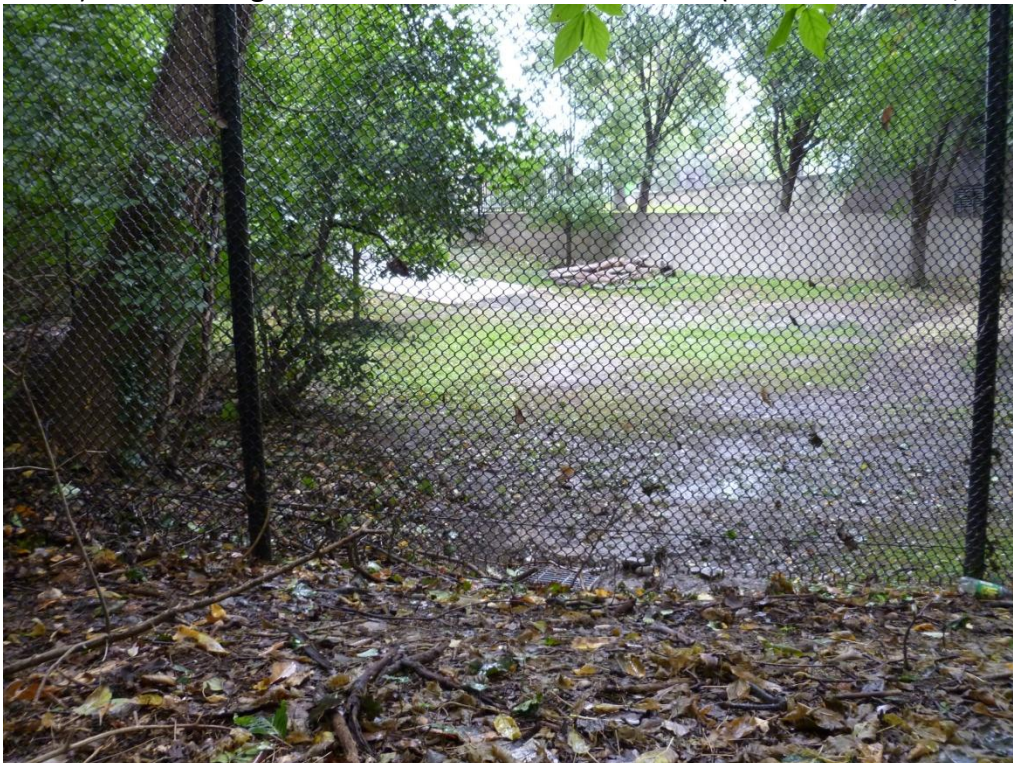
Flow exits the Naval Observatory on its northeast side from a 6" PVC pipe located above a 24" cast iron pipe, flows in this channel into the Embassy of New Zealand property where it joins New Zealand runoff and drains into a storm grate/piping (this low area and grate are shown below) that discharges into the Dumbarton Oaks Park. (October 27 and 1, 2011 photos)

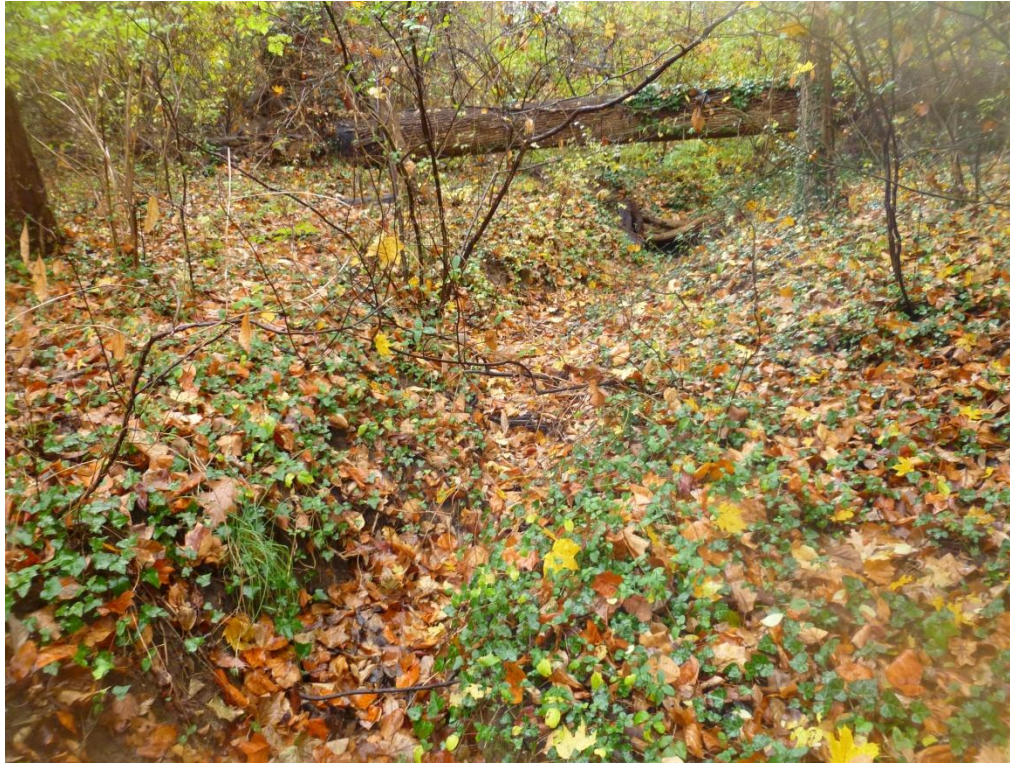
The Naval Observatory/Embassy of New Zealand combined flow leaves the Woodland area into Meadow #5 where the flow follows the west side of the Farm Track. (11-16-2011)

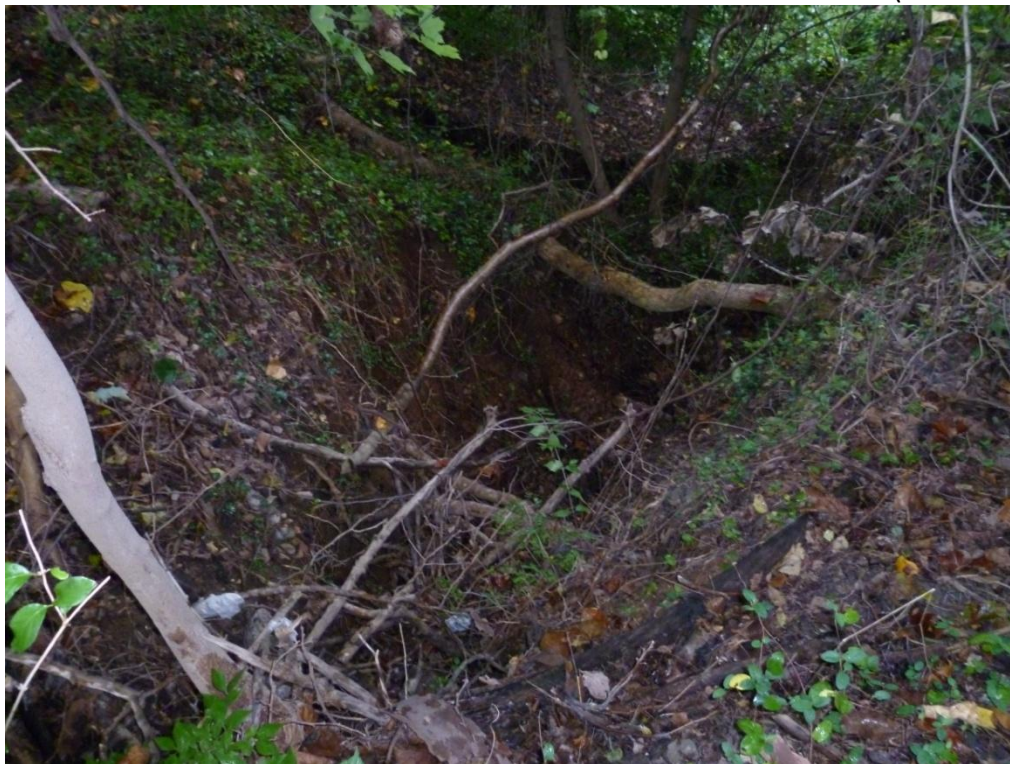
The above photo shows a gully from runoff leaving the Embassy of New Zealand property leaving the park fencing horizontal (visible at the top of the 10-1-2011 photo).

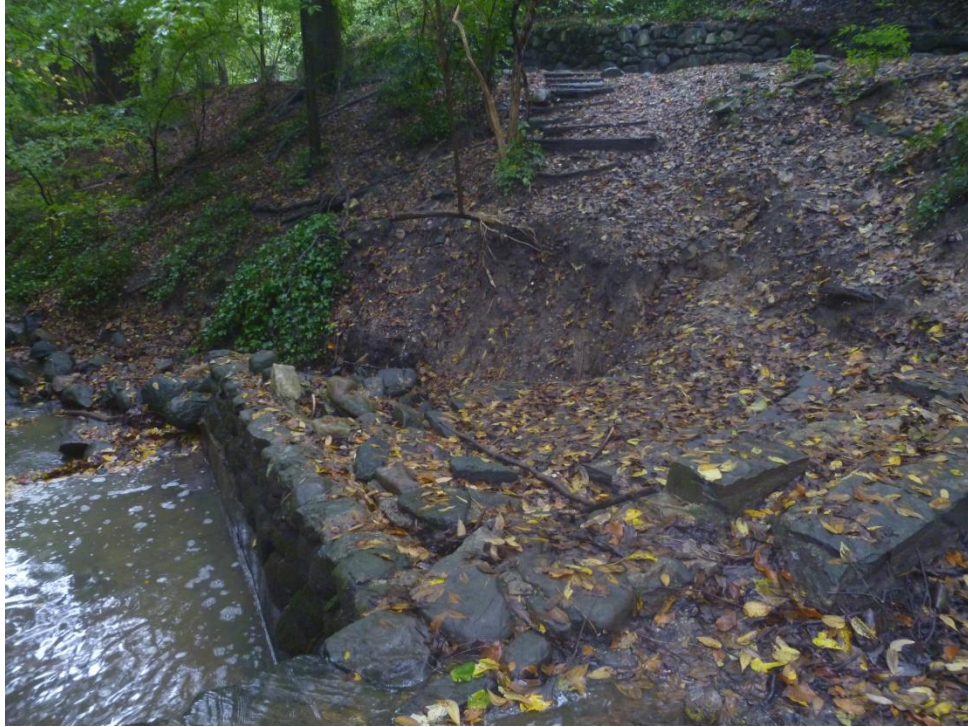
10-1-2011 photo of Dumbarton Oaks Park East Falls and the Stone Bridge. The left side of the photo shows the opening where underground flow bypasses the waterfall and exits beyond the south wing wall. The following photo (10-13-2011) documents erosion that has left patches of ivy higher than the surrounding East Falls slope.

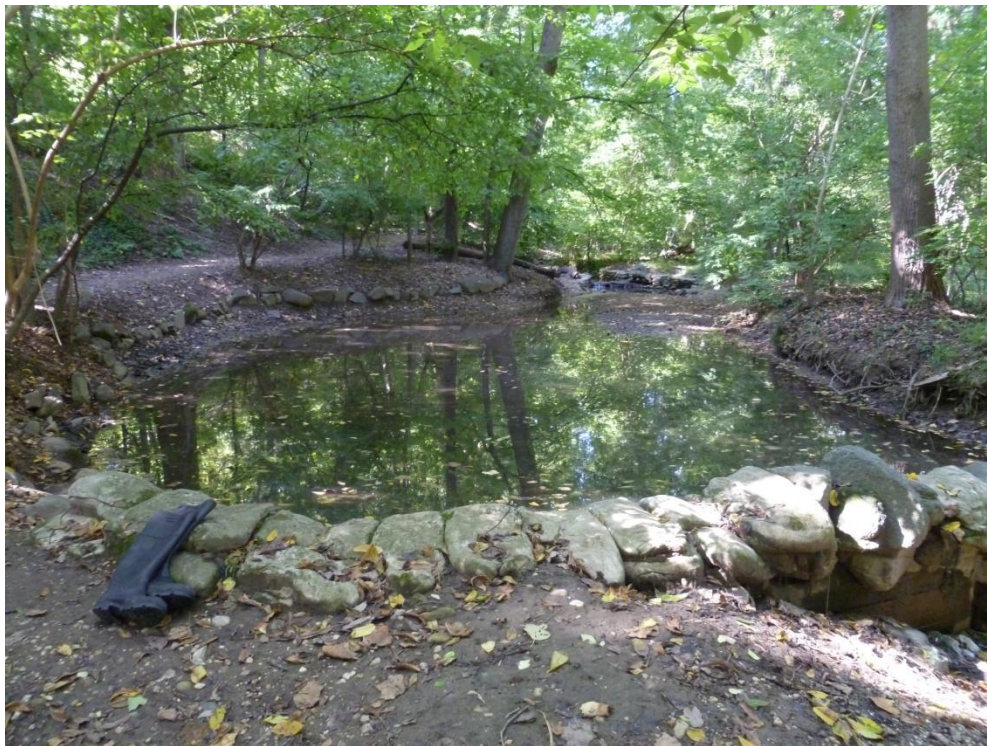
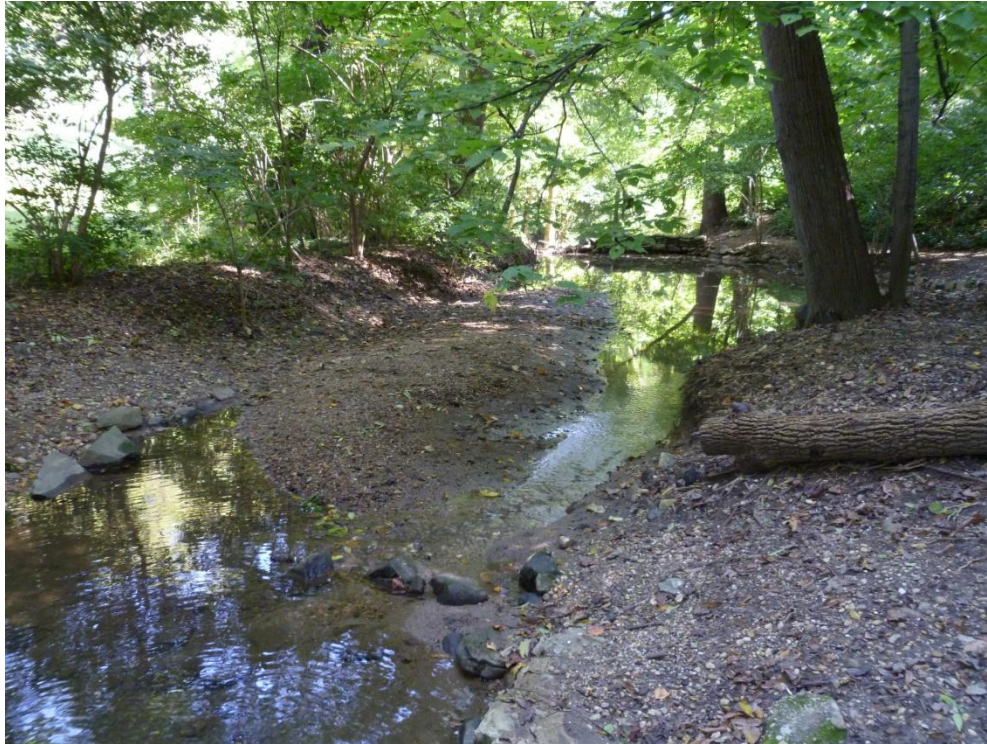
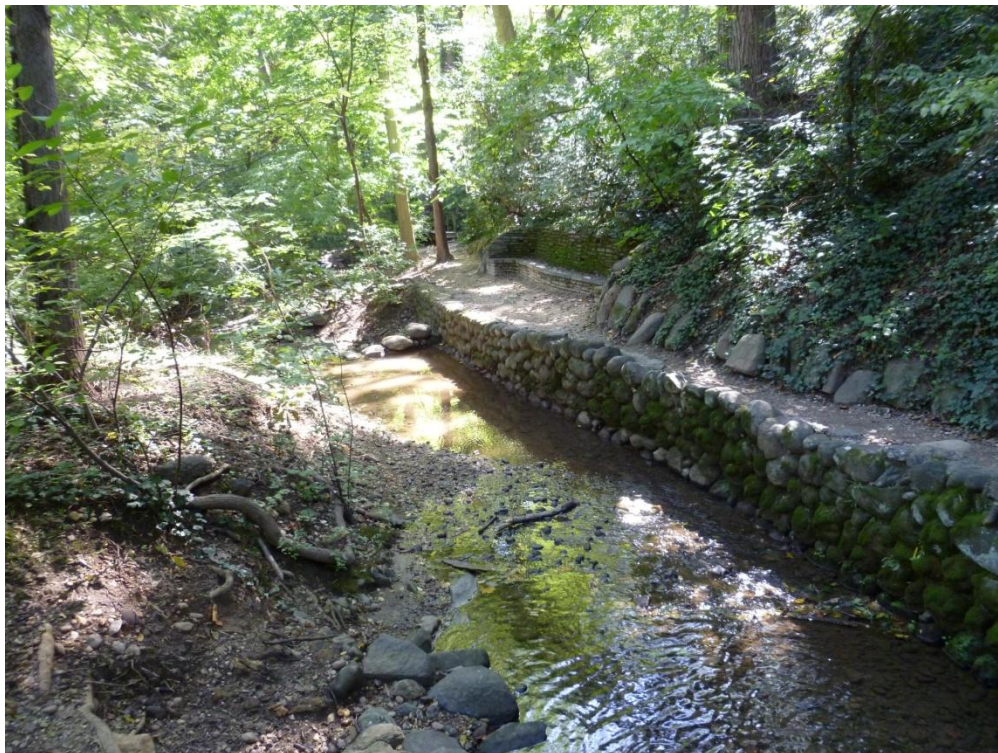
The following photos (10-6-2011) show (1) the eroded north bank of Laurel Pool that threatens the stability of established landscaping and (2) the upstream view of Laurel Pool of sediment that if removed would provide greater water storage capacity. High velocities of stormwater will require boulders or a rock wall to protect the north bank from continued erosion.

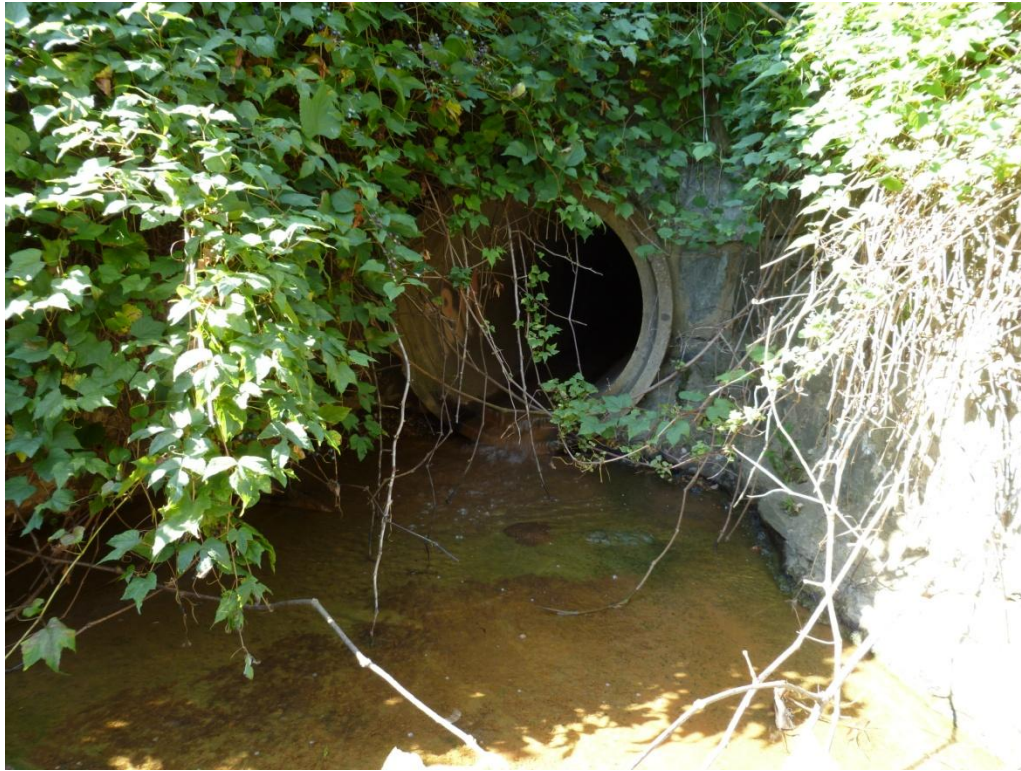
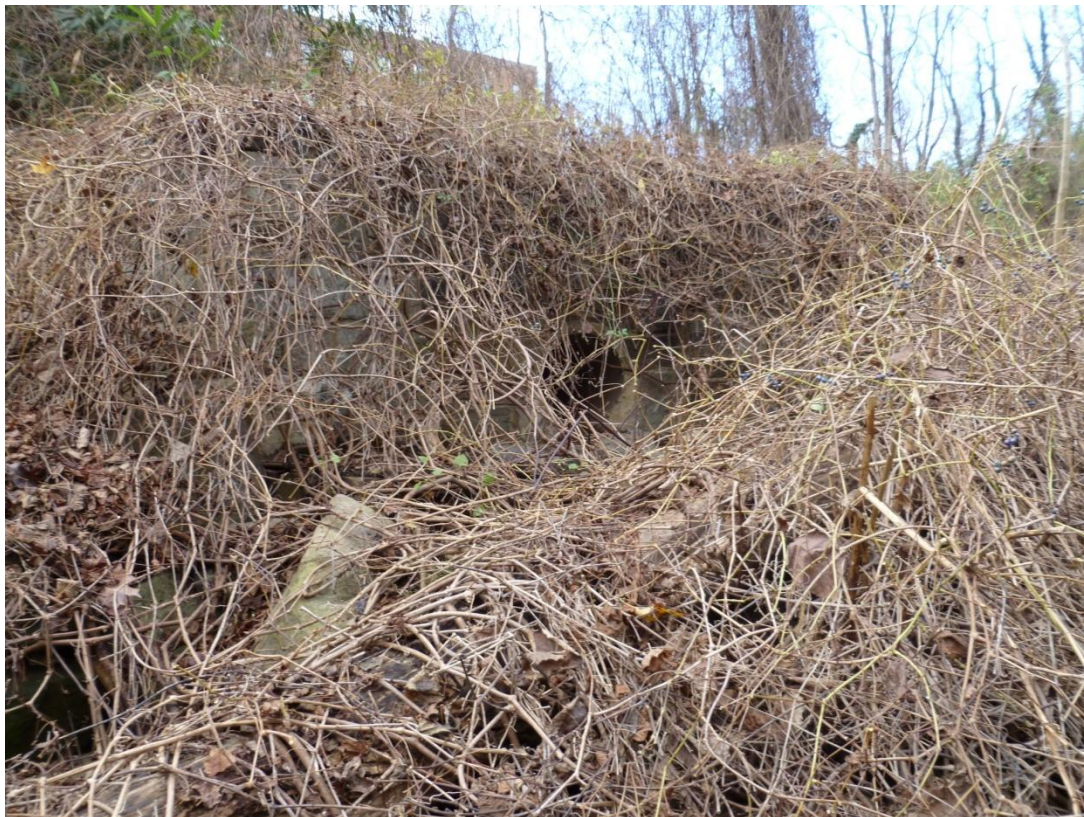
(Above) This photo provides an example of a rock wall near the Stream Arbor designed by Beatrix Jones Farrand to protect soils and Stream Path from high stream velocities. The 30" headwaters pipe is shown below. (10-6-2011 photos)

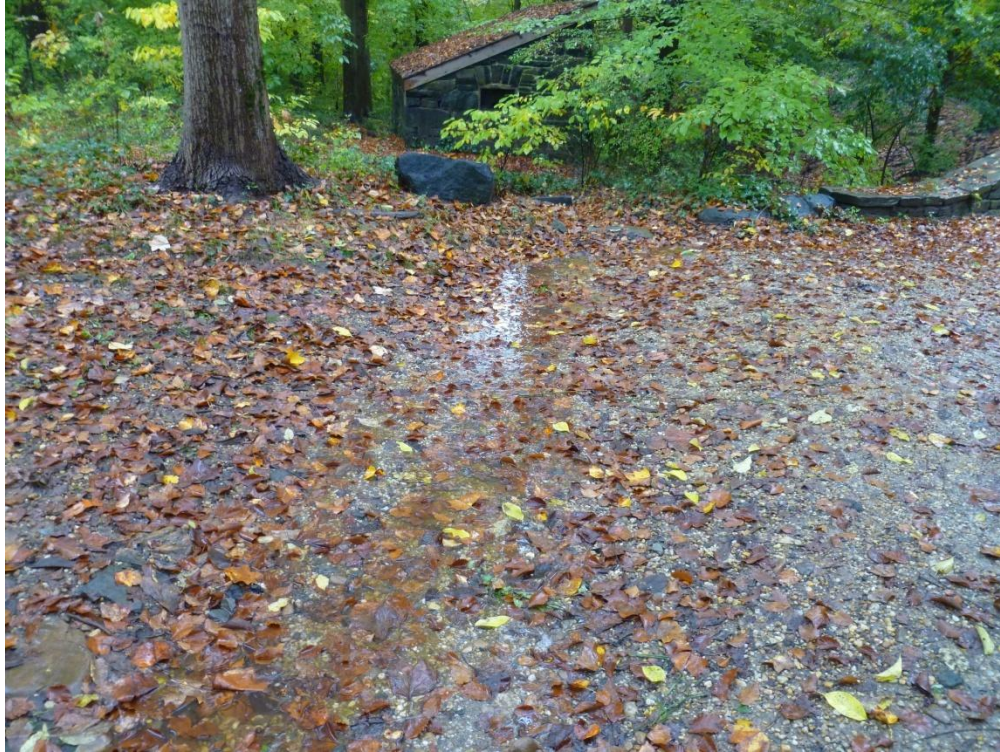
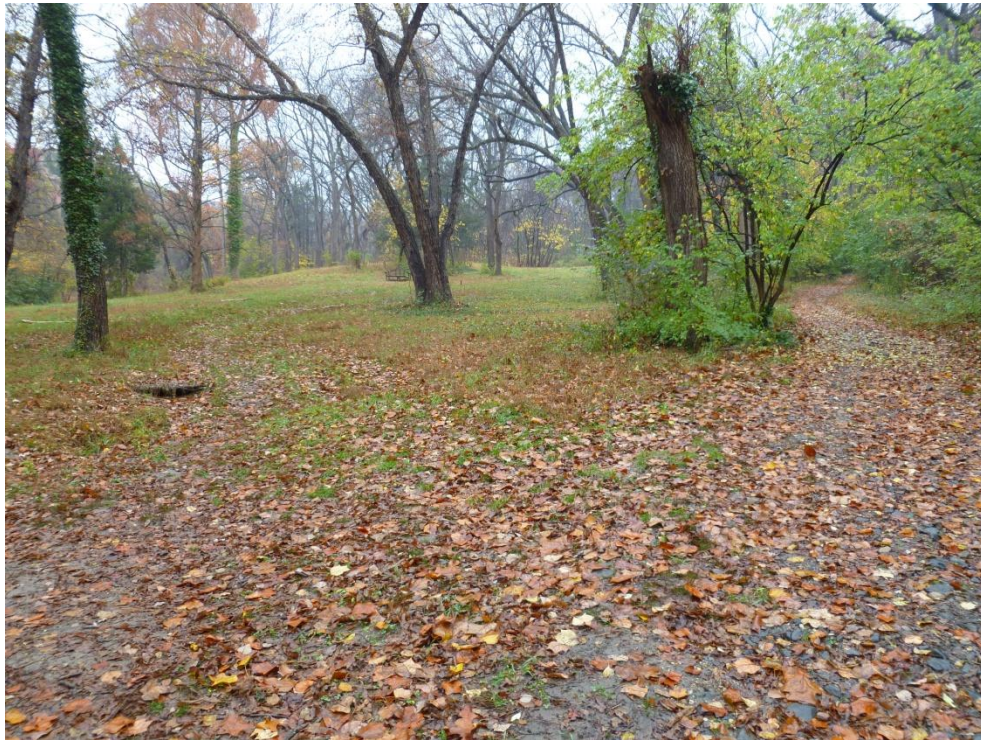
Runoff collects on the Farm Track (above) and flows to the east to drain into the stream at East Falls (below 10-20-2011 photos).

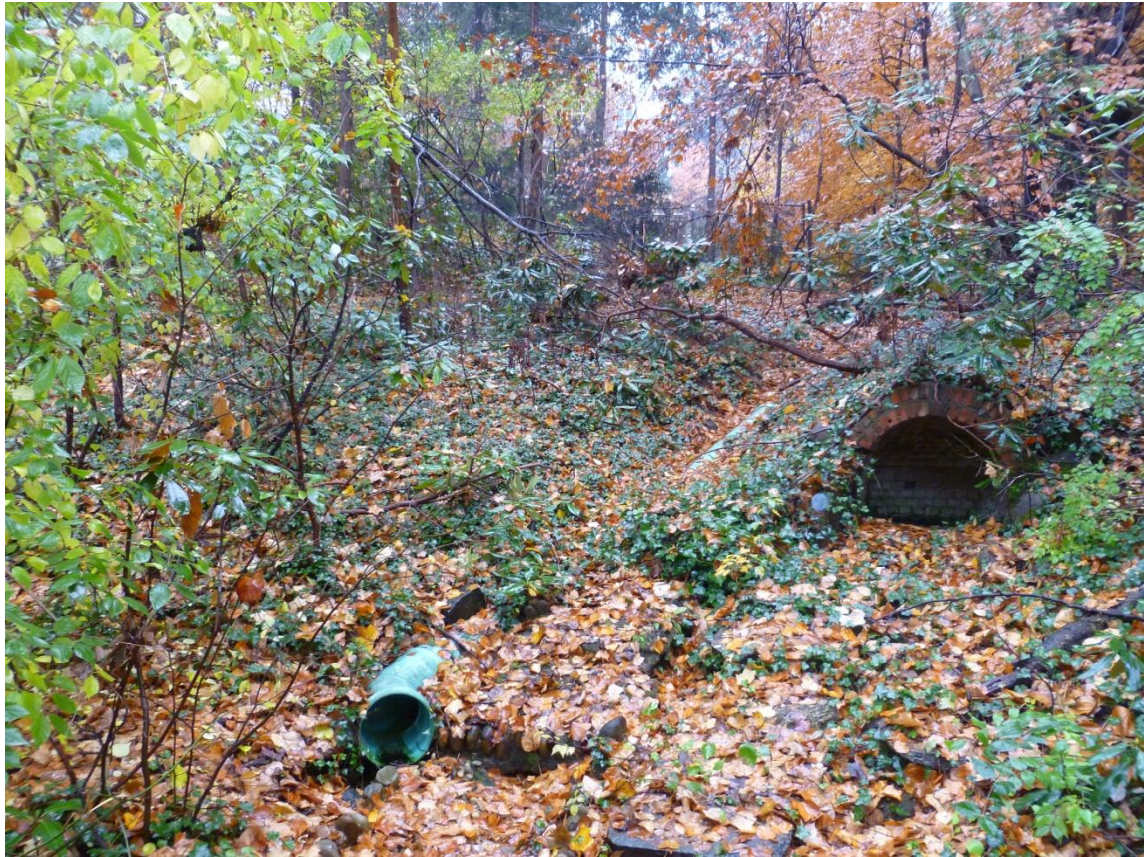
The bottom of the above photo is the area where flow from Meadow #5 merges with flow from the Farm Track to flow to the stream (10-27-2011). Below is a picture of the 12" green pipe, Pebble Stream (under the leaves), and the Spring Grotto (11-16-2011).
